Franklin County Public Health
Complete Streets Safety Audits

City of Reynoldsburg Walk Audit Summary Report

Brice Road at Livingston Avenue

APRIL 2022

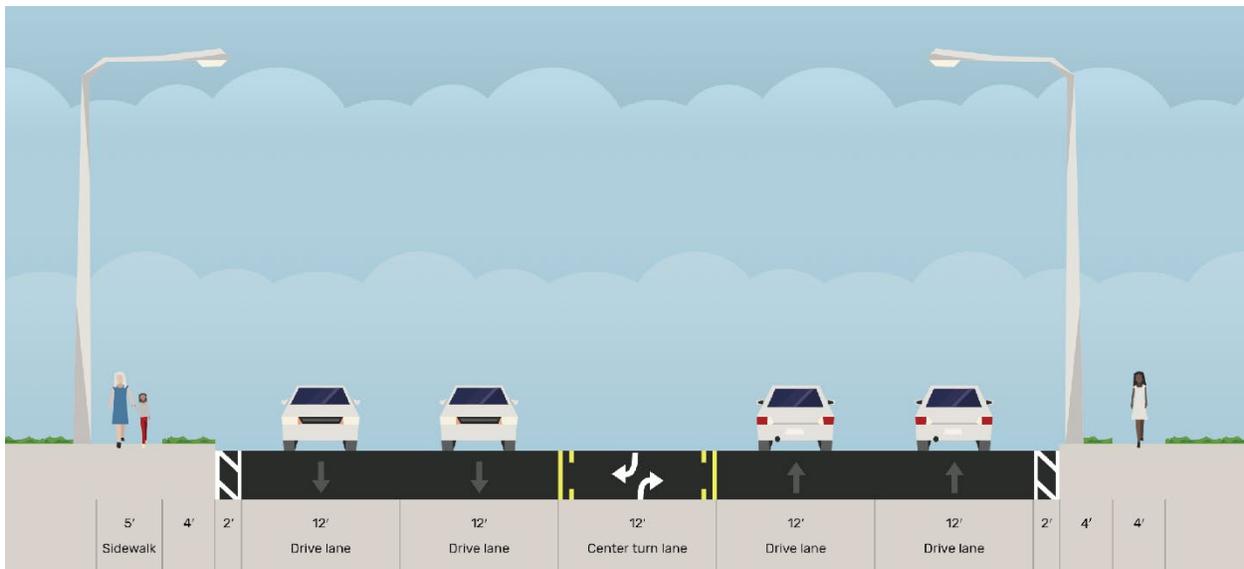
Figure 3 - Brice Road: Existing Cross Section Dimensions (South of Livingston Ave, Facing North)

The roadway width from curb to curb south of Livingston Avenue is approximately 64 feet. The approximate dimensions of the cross section for this corridor are illustrated in the image in Figure 3. A curb and gutter is present on the roadway, making the outer vehicular lanes approximately 14 feet wide. The inner two travel lanes are 12 feet wide, and the two-way left turn lane in the center is 12 feet wide. A narrow buffer of approximately 4 feet exists between the curb and the sidewalks on each side of the roadway. On the west side of the corridor there is a 5-foot wide sidewalk, while on the east side of the corridor the sidewalk is only 4 feet wide.

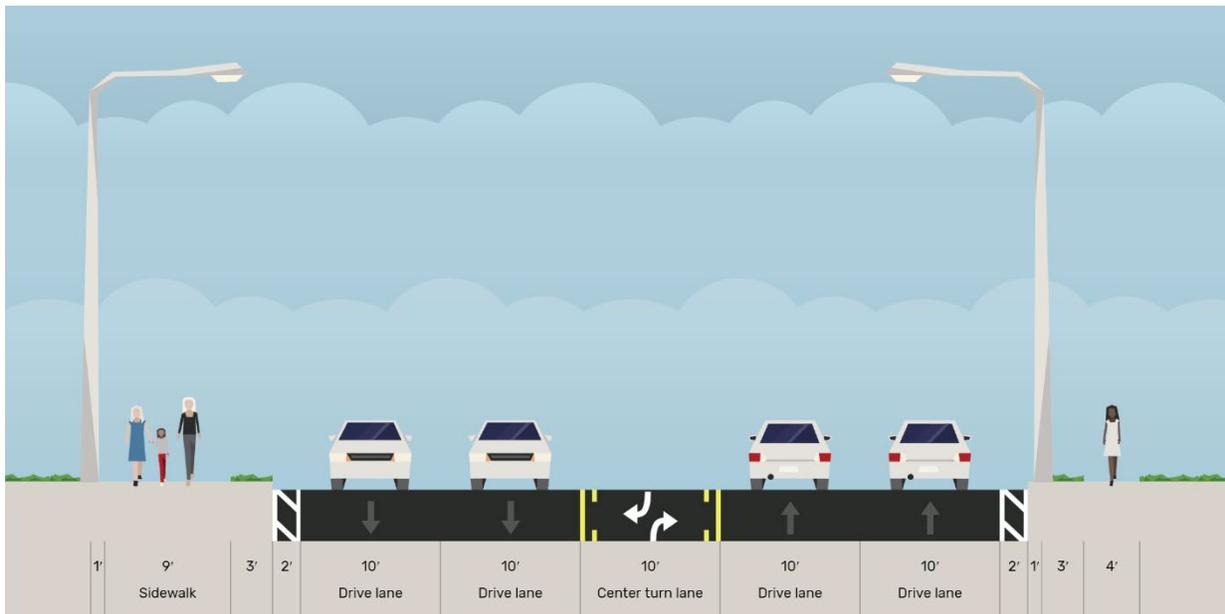
Figure 5 - Brice Road: Existing Cross Section Dimensions (North of Livingston Ave, Facing North)

The roadway width from curb to curb north of Livingston Avenue is approximately 52 feet. The approximate dimensions of the cross section for this corridor are illustrated in the image in Figure 3. A curb and gutter is present on the roadway, making the outer vehicular lanes between 11-12 feet wide. The inner three vehicular lanes (including the center turn lane) are between 9-10 feet wide. A narrow buffer of approximately 3-4 feet exists between the curb and the sidewalks on each side of the roadway. On the west side of the corridor there is a 9-foot wide shared sidewalk, while on the east side of the corridor the sidewalk is only 4 feet wide.

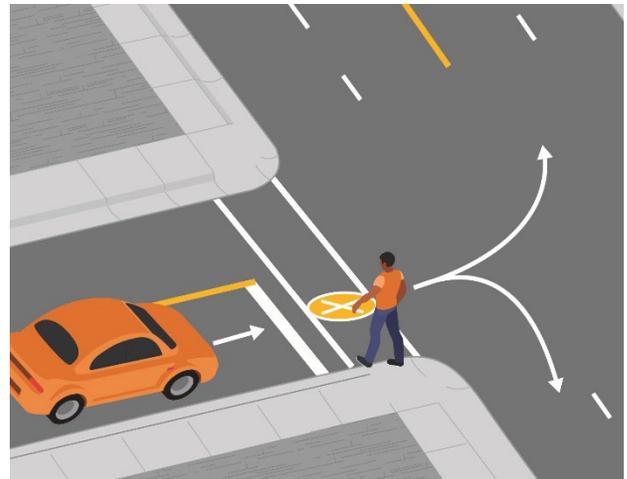
Figure 8 - Crash Type: Turning Vehicle from Side Street

- Three (3) of the crashes involving people walking resulted from similar scenarios. The person walking was traveling along Brice Road and crossing a side street within a crosswalk. Motorists traveling on the side streets did not yield to the people walking before turning onto Brice Road and struck each person walking in the crosswalk. This scenario is illustrated by the image in Figure 8. Two (2) of these crashes resulted in Property Damage Only (PDO), while the third crash resulted in minor injury. Each crash occurred on a different side street along Brice Road.

Note: The illustrations of crash scenarios were provided by ODOT and modified slightly by MORPC to represent the general scenario of the crashes reported in the study area. These images do not represent the specific locations or crashes that occurred.

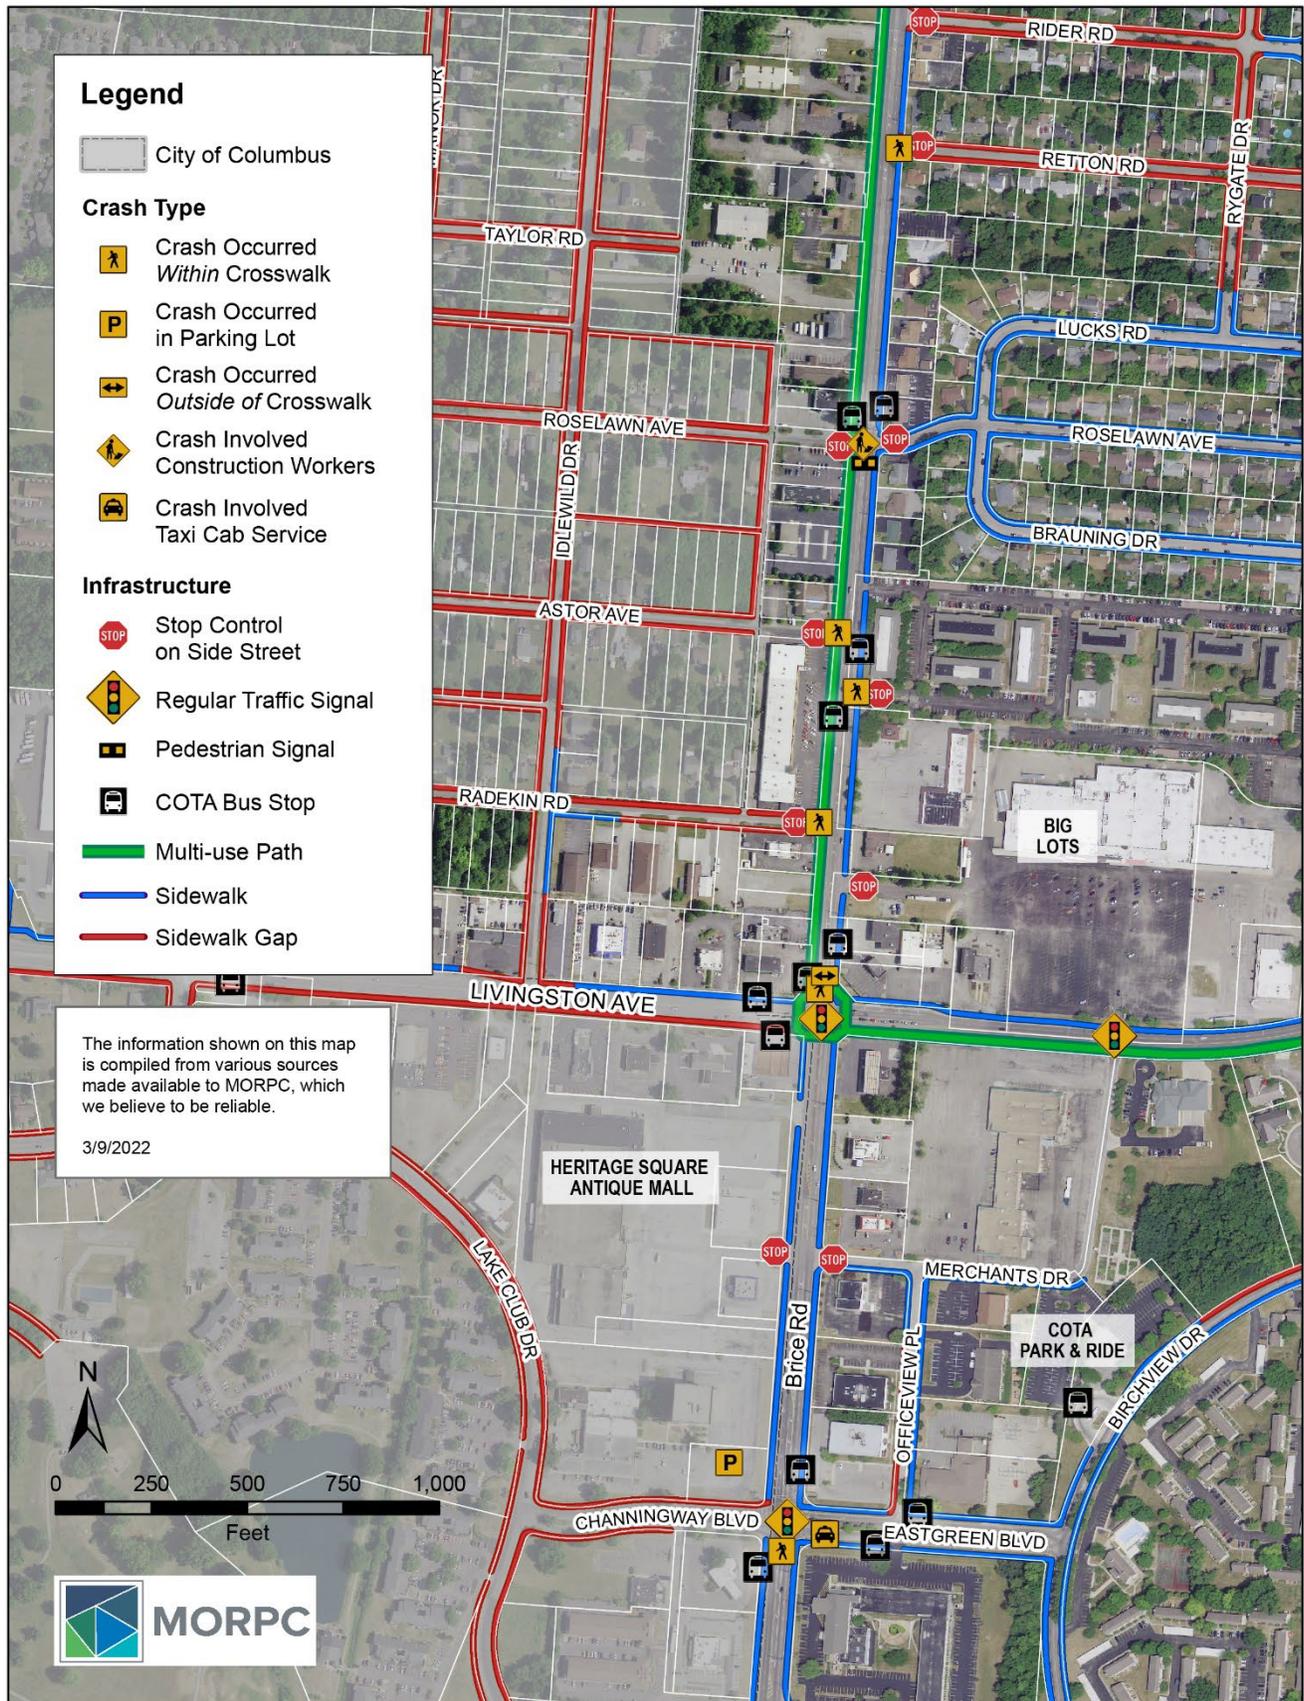
Figure 9 - Map of Crashes Involving People Walking and Bicycling 2016-2020

- Two (2) of the crashes involving people walking occurred on the north leg of the intersection of Brice Road and Livingston Avenue. One of the crash reports indicated that the person walking was crossing just north of the intersection across Brice Road, and was struck when a motorist made a left turn from eastbound Livingston Avenue onto northbound Brice Road. This crash resulted in serious injury. The second report indicated that the person walking was traveling eastbound on Livingston Avenue and crossing in the crosswalk, but had potentially crossed against the light when they were struck by a motorist traveling southbound on Brice Road. This crash resulted in possible injury.

- The remaining two (2) crashes occurred just off Brice Road. One (1) of the crashes occurred in the parking lot off Channingway Boulevard and involved a tow truck operator loading a vehicle onto a tow truck. The second crash occurred on Eastgreen Boulevard and involved someone being picked up by a taxi being struck by the motorist driving the taxi.

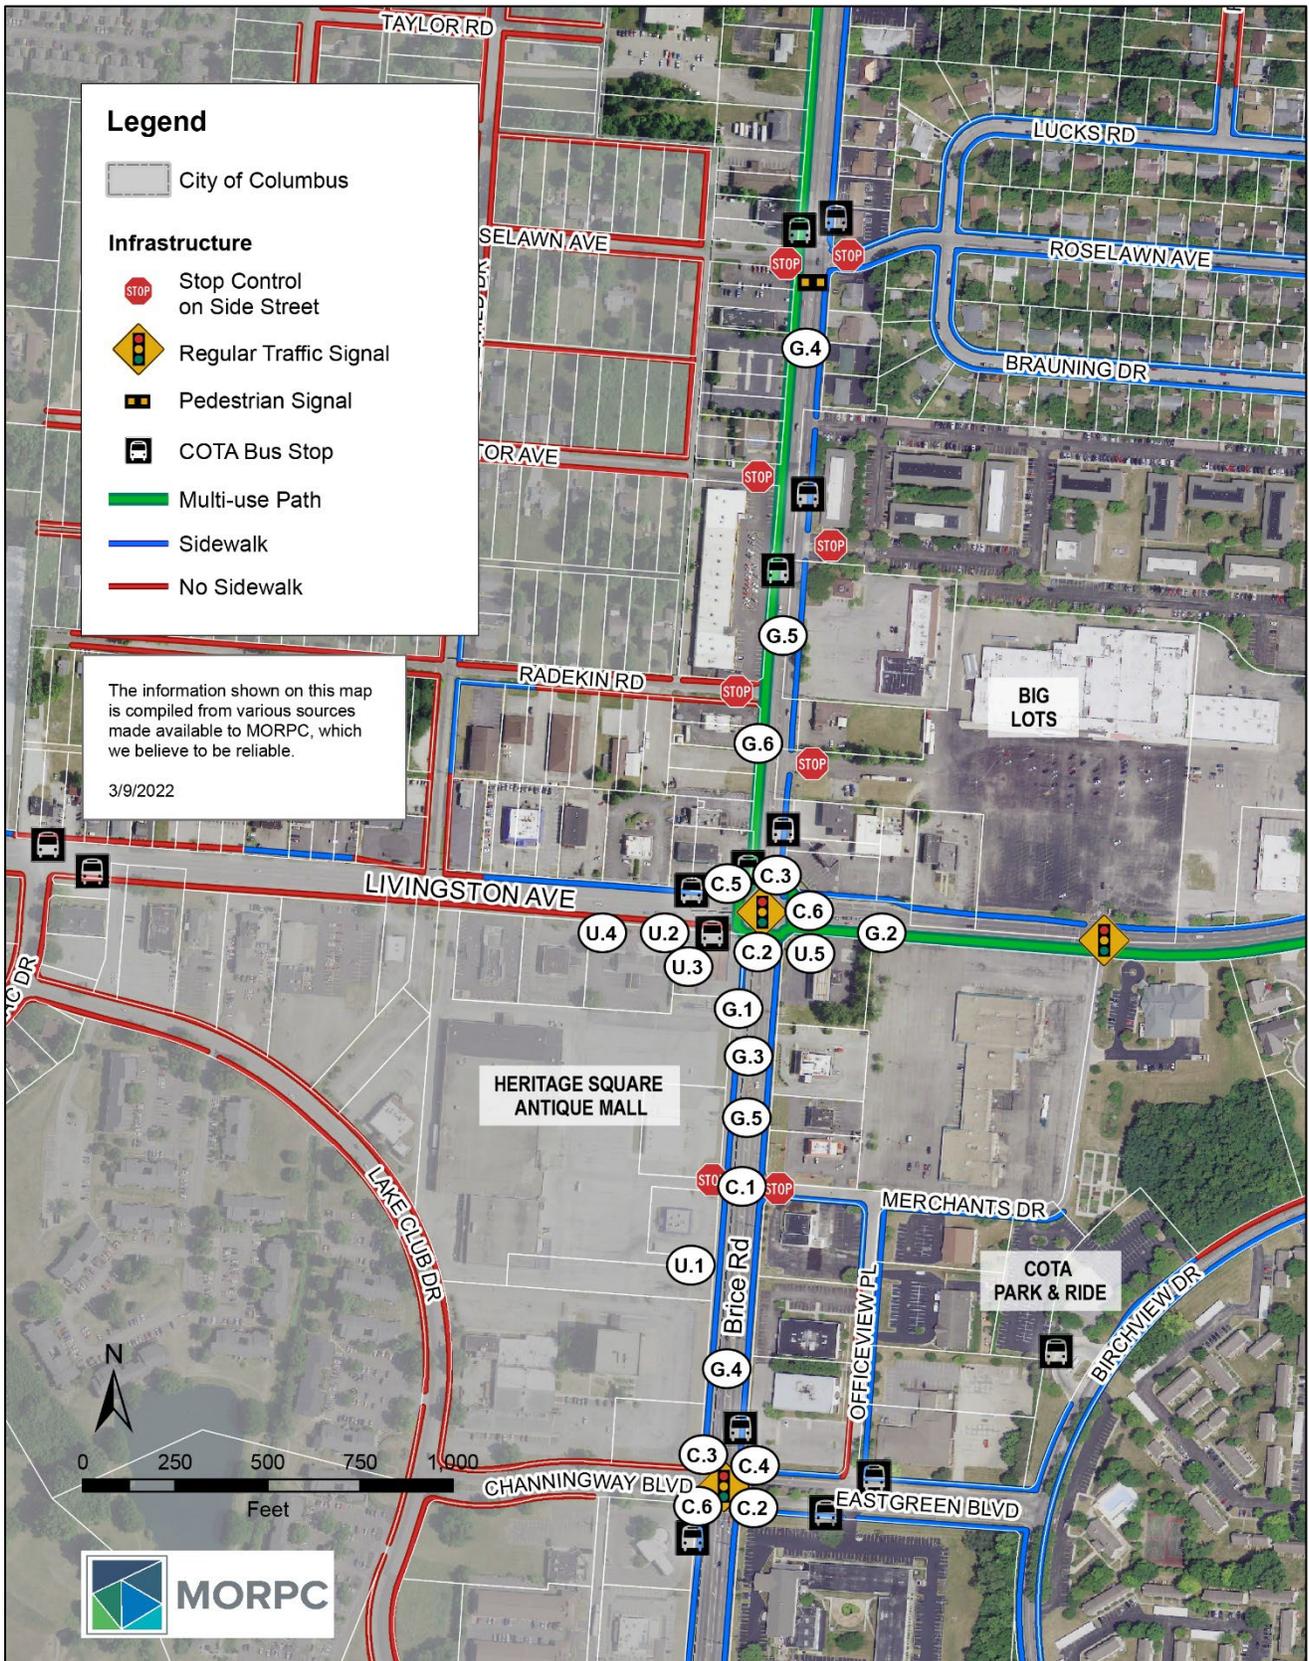
Figure 11 - Map of Walk Audit Observations

G.6	The sidewalks and shared use path along Brice Rd north of Livingston Ave are broken up by numerous driveways.
Crossings and Intersections Observations	
C.1	Merchants Drive appears to be an intersection where pedestrians might be crossing Brice Road.
C.2	Crosswalk markings along the corridor are low visibility (standard) and faded in many locations.
C.3	The length of the pedestrian crossings on Brice Rd are 68-70ft (depending on the intersection).
C.4	The pedestrian signal phase for crossing Brice Rd at Channingway Blvd is between 15 to 20 seconds in length – just barely enough time for an able-bodied pedestrian to cross.
C.5	The pedestrian signal pole at the NW corner of Brice Rd and Livingston Ave intersection is in center of sidewalk/SUP (potential obstacle for mobility-impaired users).
C.6	Pedestrian signals at all intersections are activated by push-button; not audible.
User Behavior Observations

U.1	Vehicle speeds between Livingston Ave and Channingway Blvd recorded during the audit were around the posted speed limit (30 – 40 MPH).
U.2	COTA buses (Route 1 EB) often let passengers out before reaching the stop location on Livingston west of Brice – passengers cross Livingston outside of the intersection.
U.3	COTA buses (Route 1 EB) often holdover at the bus stop in front of the Speedway and block traffic at the intersection of Livingston Ave and Brice Rd.
U.4	It was noted that schoolchildren are often observed walking along the south side of Livingston Ave west of Brice Rd, where there is no sidewalk.
U.5	Right-turning motorists at Brice Rd and Livingston Ave do not anticipate needing to yield for pedestrians in the crosswalk.

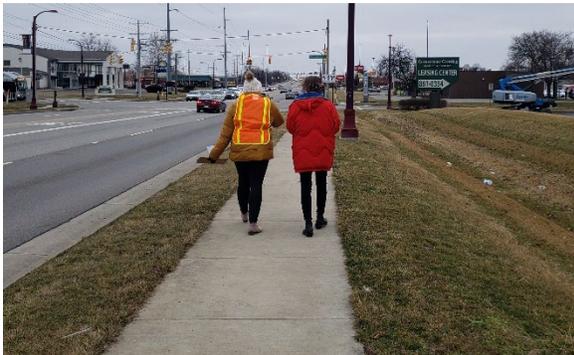
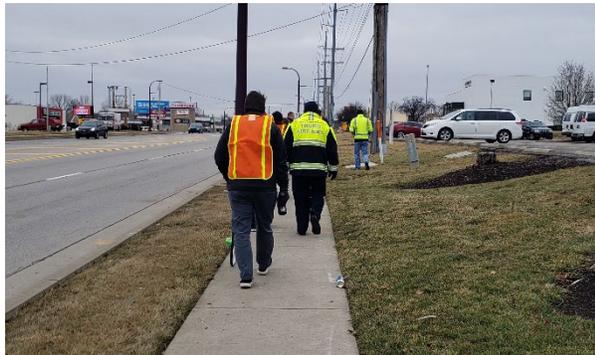
West Side of Brice Road (5-foot Sidewalk)

East Side of Brice Road (4-foot Sidewalk)

The sidewalk on the west side of Brice Road south of Livingston Avenue is 5 feet wide, while the sidewalk on the east side is only 4 feet wide. A 4-foot (48 inch) wide sidewalk is not wide enough for two people to walk side-by-side, or pass each other comfortably traveling in opposite directions. A 5-foot wide sidewalk provides the minimum space necessary for two people to walk side-by-side, or to pass each other comfortably.

Standard sidewalk widths should be a minimum of 4 feet wide in constrained conditions, with a preference for 5 feet as a minimum. A sidewalk wider than 5 feet is preferred as pedestrian volumes increase, and would be desirable with any future redevelopment of the Brice Road corridor.

It is recommended that the existing shared use path along the northern segment of Brice Road be continued southward to connect with the facilities currently planned as part of the ODOT Far East Freeway project. This could be completed as the corridor redevelops, or as a reconstruction project.

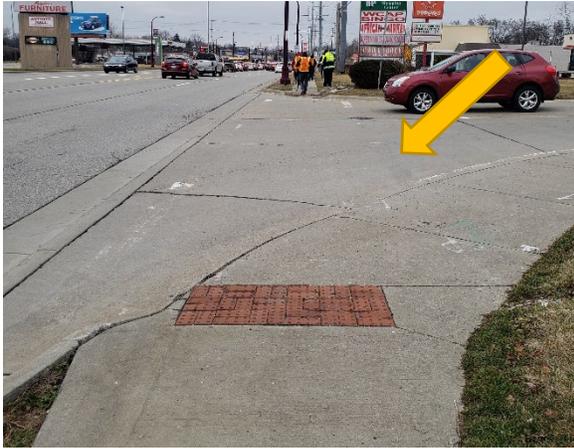
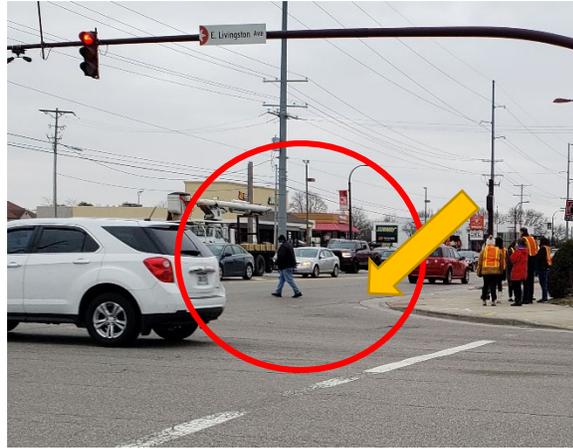
Intersection of Brice Road and Merchants Drive

Intersection of Livingston Avenue and Brice Rd

The existing pedestrian crossing markings throughout the study area are standard, transverse lines that fade quickly in areas with high vehicular traffic. These markings are considered low visibility, and are often mistaken as stop bars by motorists stopping at intersections – especially once they have started fading. This can create potential conflicts, as motorists may not be aware of the crosswalk or expect there to be people crossing the street in front of them. It is also common for motorists to pull forward into the crosswalk and block the crossing for pedestrians.

High visibility crosswalk markings are recommended for use as the standard crosswalk marking. They are more visible to motorists, have been shown to increase yielding behavior of motorists, and can be implemented in a manner that reduces wear and maintenance requirements. High visibility crosswalk markings include three general types: longitudinal bars/continental, ladder, and bar pairs. Existing crosswalk markings can be upgraded to high visibility markings as they require maintenance, and intersections that do not currently have any markings should be marked with high visibility markings.

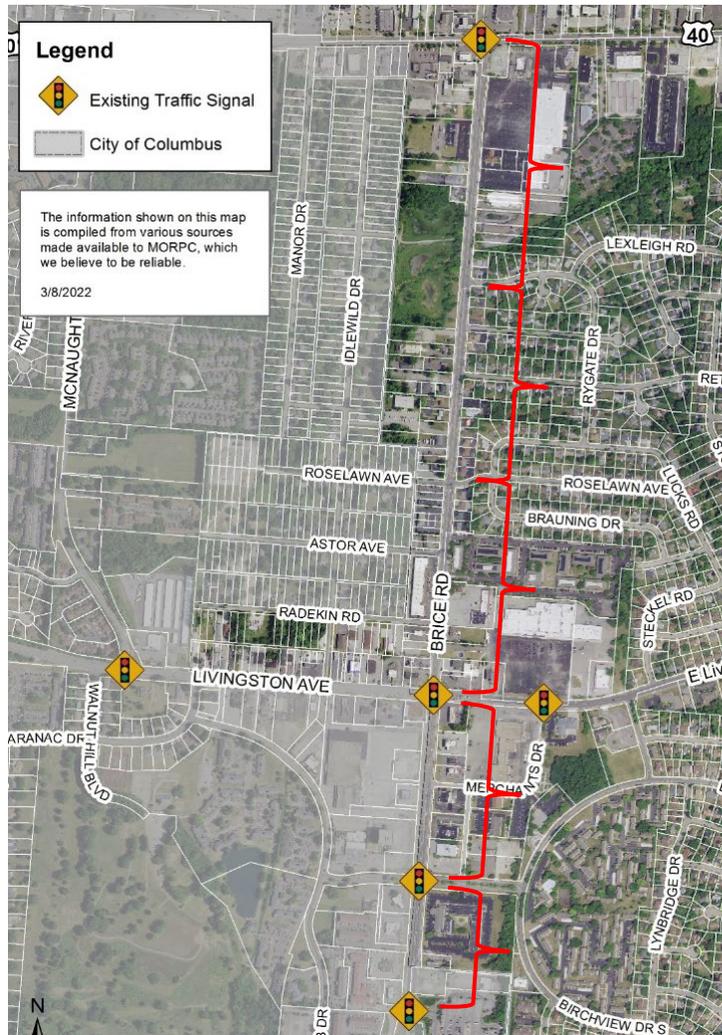
Observation #3: Distance Between Marked / Signalized Pedestrian Crossings

Main Street to Rygate Drive
(Pedestrian Signal @ Rygate)
1,700 feet or ~1/3 mile

Rygate Drive to Roselawn Avenue
(Pedestrian Signal at Both Locations)
1,400 feet or ~1/4 mile

For a corridor such as Brice Road, these crossings would require high visibility crosswalk markings and additional infrastructure treatments (e.g., median or pedestrian refuge island, rectangular rapid-flashing beacon or pedestrian hybrid beacon, etc.) in order to provide an adequately safe crossing. The ODOT MMDG recommends following existing guidance provided by the FHWA for designing uncontrolled pedestrian crossings. (4.4.3. *Selecting Pedestrian Crossing Treatments*)

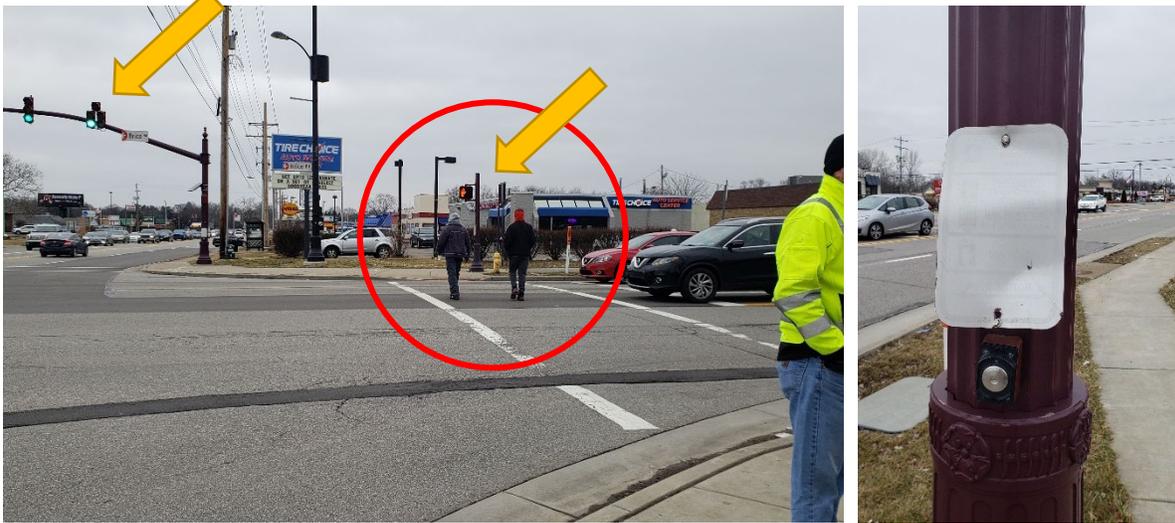
Intersection of Brice Road and Livingston Avenue (North Leg)

The pedestrian walk signals throughout the study area are pushbutton activated, which means a pedestrian must push the button in order to receive a walk signal – even when the parallel vehicular traffic has a green light. Most pedestrians who see a green light will use that opportunity to cross the street, even when the associated walk signal is not active.

The pedestrian pushbutton sign at this particular location (NE corner of the intersection) is completely faded. If the pushbuttons are to remain, it is recommended that the signage be replaced.

The ODOT MMDG recommends the use of 3.0 feet per second to program the pedestrian signal phase to accommodate slower pedestrians, particularly at intersections where there are more than two travel lanes to cross or the posted speed limit is above 30 mph. (8.3.3. Signal Timing and Reducing Pedestrian Delay)

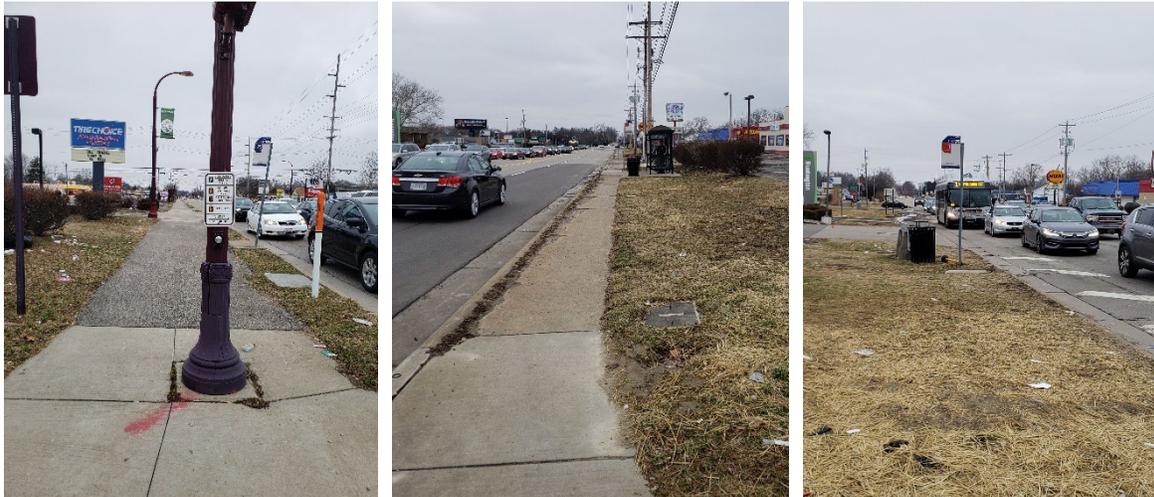
Intersection of Brice Road and Livingston Avenue (West Leg)

Traffic signal poles and other infrastructure placed within the right-of-way represent obstacles for those who are visually and/or mobility impaired. The pedestrian signal pole at the northwest corner of the Brice Road and Livingston Avenue intersection was placed in the center of the shared use path. While there is a wide enough space to provide an ADA-accessible pathway, the signal pole may still be an obstacle for someone who is visually and/or mobility impaired navigating this corner.

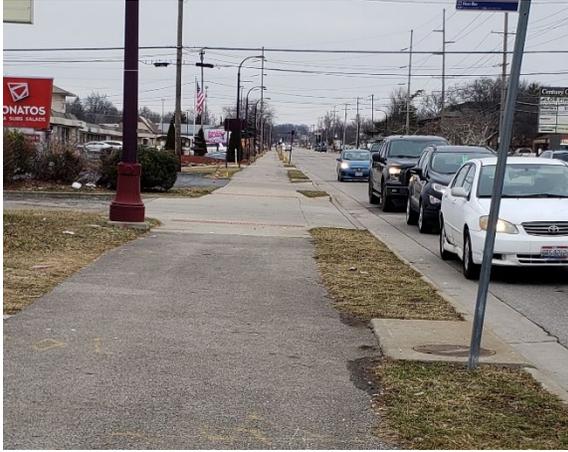
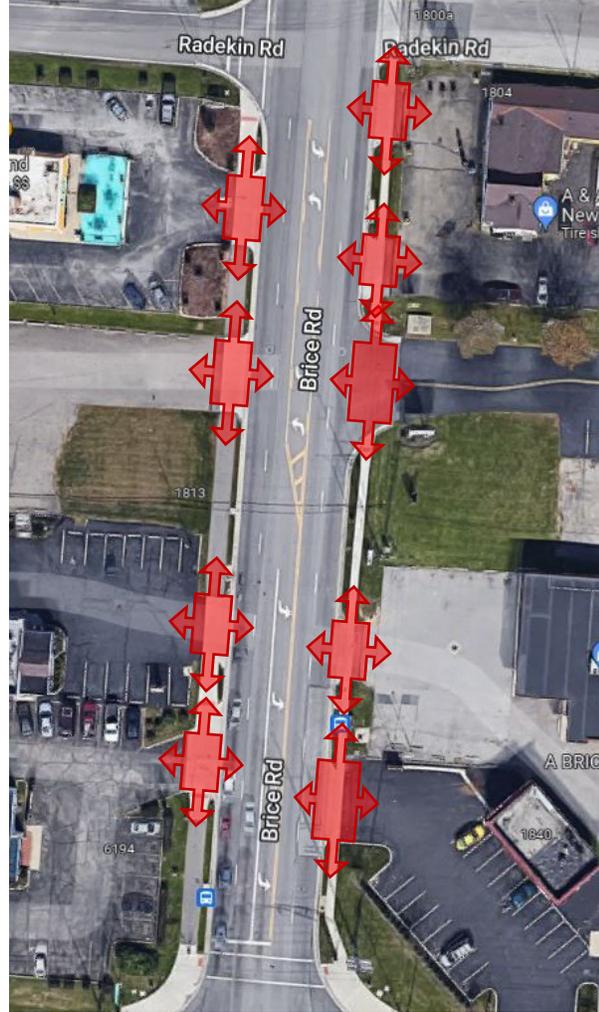
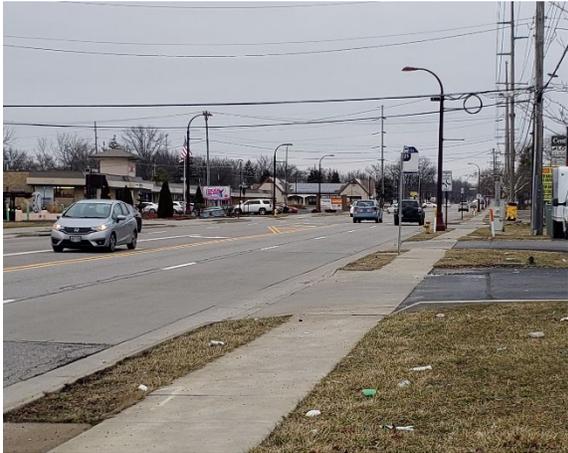
Driveways Along West Side of Brice Road

Brice Road North of Livingston Avenue

Driveways Along East Side of Brice Road

There are numerous driveways along Brice Road north of Livingston Avenue that break up the continuity of the sidewalk and shared use path along the street. These driveways create conflict points for people using the walkways, but also for motorists traveling along Brice Road. Turning movements into and out of this many driveways can cause traffic back-ups and crashes if motorists are not careful. Driveways that are located too close to intersections can also cause operational and safety challenges.

Driveways along Brice Road, particularly north of Livingston Avenue, should be redesigned and/or consolidated per recommended standards for access management. Driveways that are currently too close together should be consolidated and provided alternative access/connectivity within the property(s) or from another location.

For a roadway such as Brice Road – an arterial street with a posted speed limit of 35 mph – the minimum distance that should be provided between relatively low volume driveways (less than 50 trips per hour at peak) is 50 feet. However, ODOT guidance recommends a distance of 250 feet for ideal operating conditions. (ODOT SHAMM Section 4.0 Driveways)

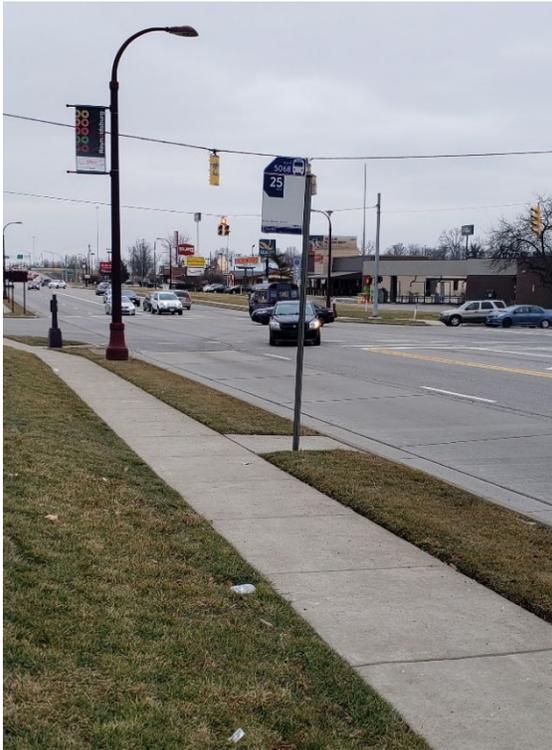
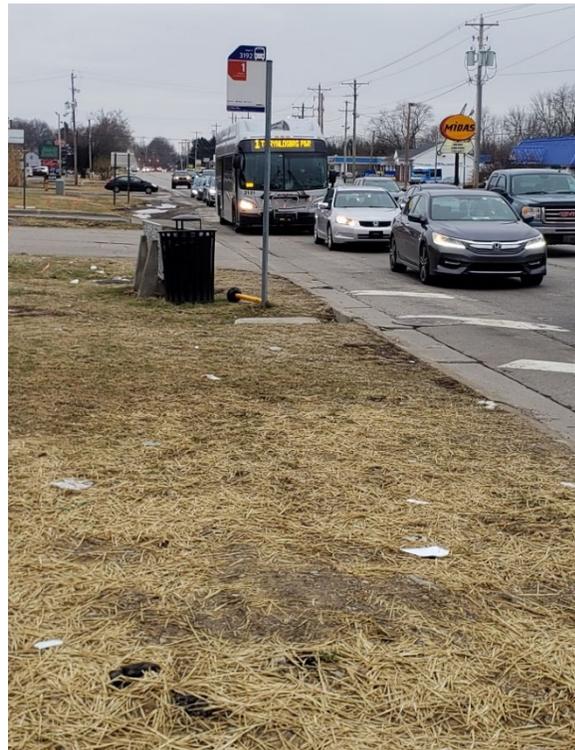
Bus Stop on Brice Road (Northbound)

Bus Stop on Livingston Avenue (Eastbound)

COTA Route 1 currently operates along Livingston Avenue, with the route terminus at the Brice Road Park and Ride. This service operates on a frequent basis with headways of 15 minutes or less. The route provides a direct connection between the City of Reynoldsburg and downtown Columbus. COTA Route 25 also operates in this area along Brice Road, traveling between Easton Town Center and Canal Winchester. This service operates on 60-minute headways, or once an hour.

The busiest bus stops in the study area are the two stops along Livingston Avenue just west of the intersection with Brice Road. The stop on the north side of Livingston Avenue has a shelter, bench, and other stop amenities that reflect the high ridership at this location. However, the stop on the south side of Livingston Avenue currently sits on a dirt pad with no sidewalk connectivity. It was noted by walk audit participants that the bus often stops to layover at this location, blocking traffic flow on Livingston Avenue. Additionally, during the walk audit, the bus was observed stopping in traffic behind the bus stop and letting passengers off early. The passengers then proceeded to cross Livingston Avenue mid-block.

It is recommended that every bus stop location be upgraded to include (at minimum) an accessible boarding and alighting area, as required by ADA and PROWAG, as well as appropriate sidewalk connectivity. An accessible boarding and alighting area requires no less than 5 feet in width parallel to the curb and 8 feet in depth perpendicular to the curb that is free of any obstructions. This pad may be a part of the pedestrian pathway or sidewalk.

It is also recommended that the City of Reynoldsburg collaborate with the City of Columbus and adjacent property owners to determine the feasibility of creating a bus pull-off area in the eastbound approach of Livingston Avenue to Brice Road. This would ideally be designed to allow the bus to pull out of the vehicular travel lanes to reach the bus stop without having to stop for a second traffic signal cycle. This should also include installation of appropriate bus stop amenities as noted above. The bus pull-off area could also double as a right-turn lane, allowing the bus to easily continue along its route southward along Brice Road.

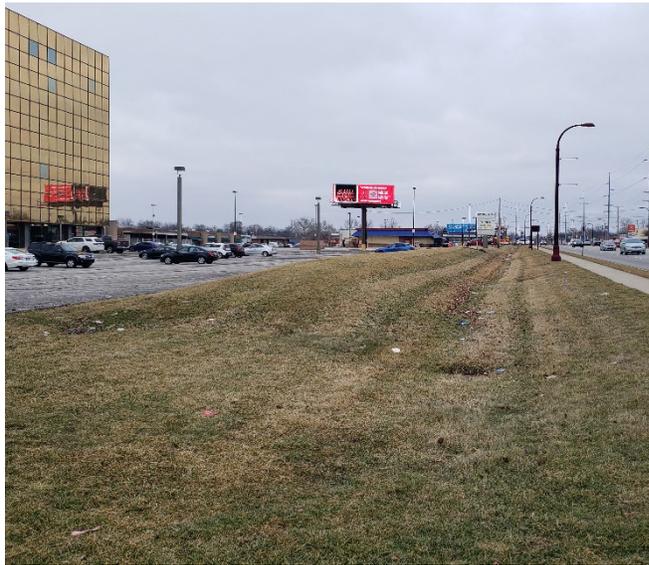
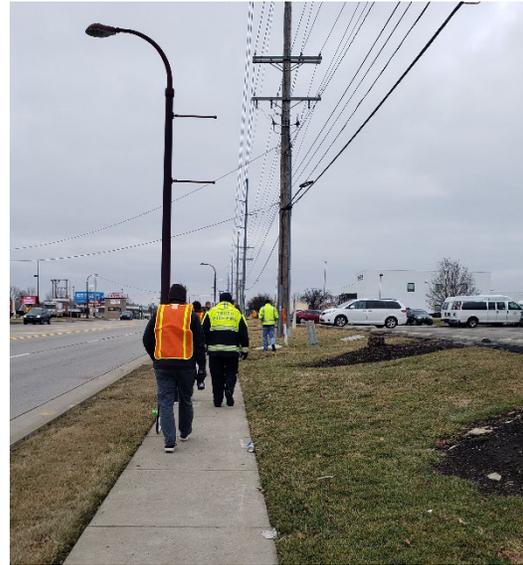
Large Grass Swale on West Side of Brice Road

Overhead Street Lighting on East Side

The land uses and development adjacent to Brice Road are primarily commercial/retail with significant parking lot frontage. Along much of the corridor there is a landscape buffer between the parking lots and sidewalk, but it primarily consists of grass lawns or swales that collect trash. There are also narrow buffers present between the sidewalk and curb that help to separate pedestrians on the sidewalk from the adjacent motor vehicle traffic.

There is a lot of opportunity along the Brice Road corridor to redevelop, repurpose, and/or redesign these spaces to enhance walkability and the attractiveness of the corridor. The Envision Reynoldsburg Comprehensive Plan already identifies many design features that would be recommended for improving the general walking environment along this corridor. This includes shifting parking lots to the rear of new buildings, screening parking lots with attractive landscaping, installing street trees and/or green infrastructure, and establishing the corridor as a gateway into the City of Reynoldsburg.

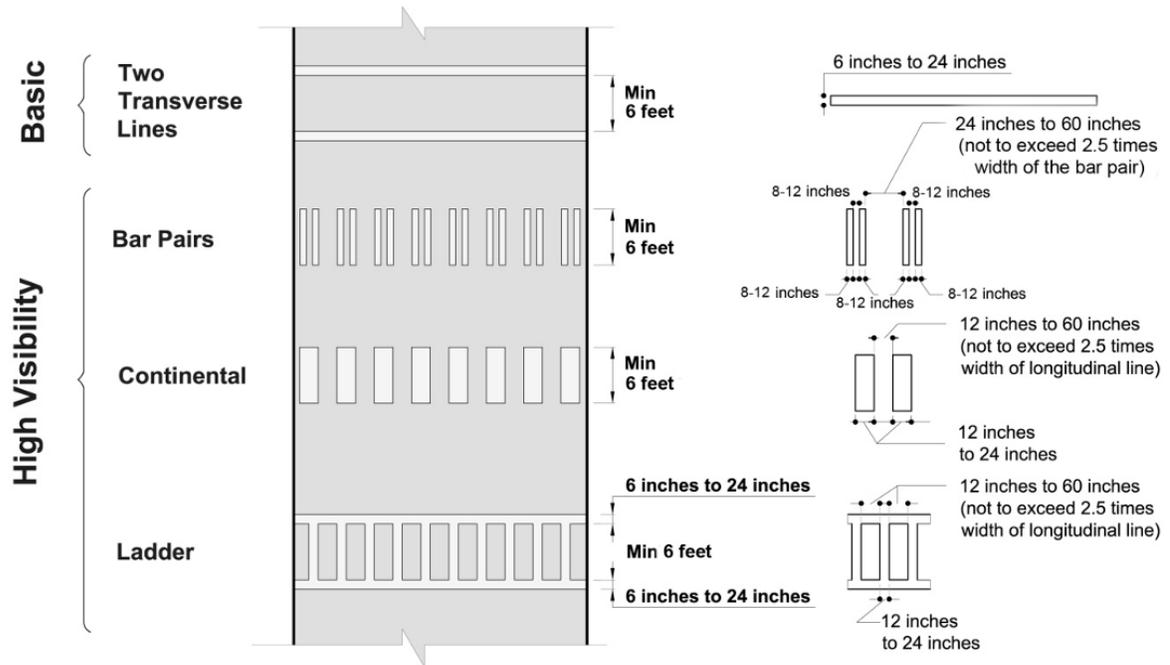
Crosswalk Marking Types

The image below was proposed by the National Committee on Uniform Traffic Control Devices to replace the existing Figure 3B-19 in the Manual on Uniform Traffic Control Devices (MUTCD). The image displays examples of crosswalk markings and classifies them as basic or high visibility.

Note: At a non-intersection uncontrolled pedestrian crossing where the speed limit is greater than 35 mph, the high visibility crosswalk marking, if used, should not be less than 8 feet wide.

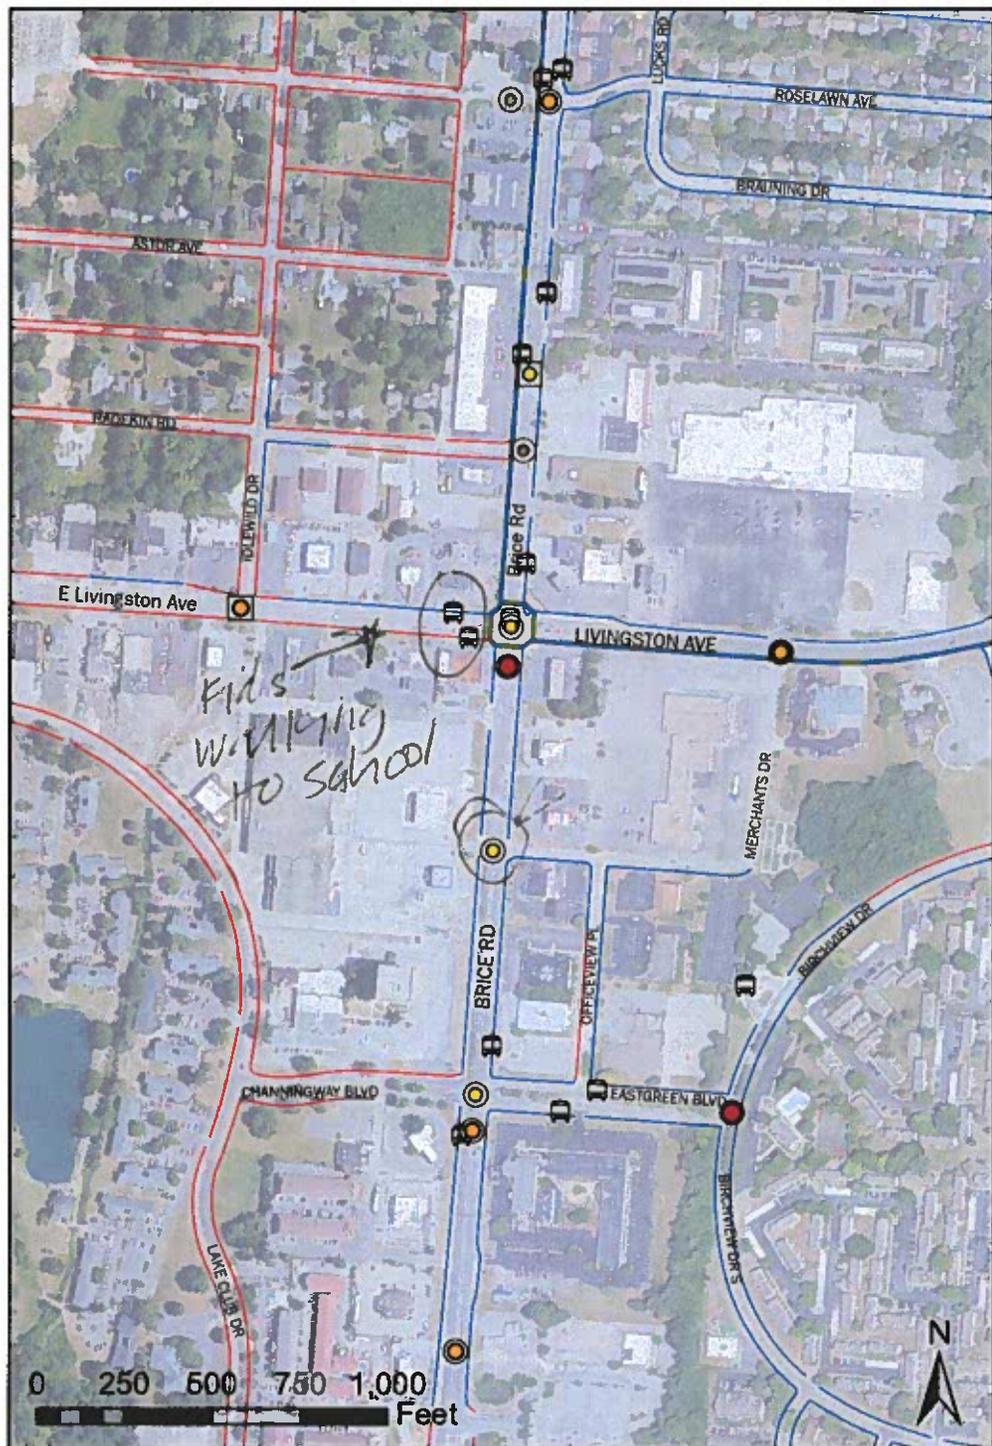
Notes:

is merchants a legal crossing?

I think a lot of issues could be solved by adding bike path/sidewalk on Livingston, Columbus side with street lights. Reynoldsburg side would benefit by changing one of the sidewalks along Brice Rd. to a bike path.

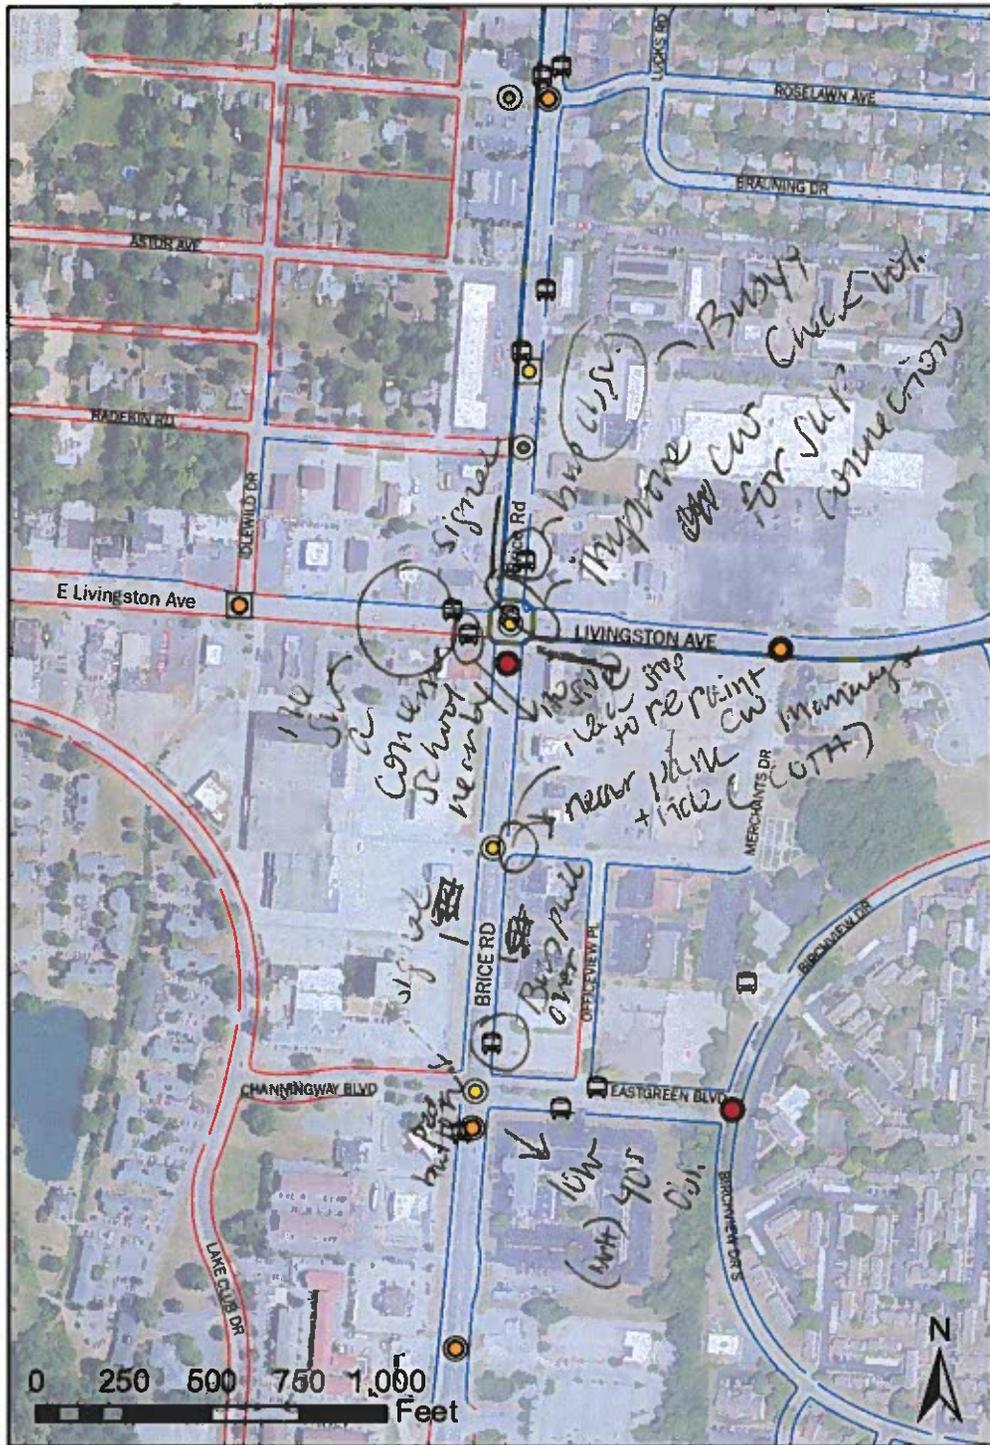
Notes:

38 / 39 MPH @ Brice/Merchant
 (Speed limit 35)
 68 ft crosswalk Brice @ Channingway
~~15~~ sec to cross ~~15~~ sec
 15 sec countdown, few sec before starts
 ~ 20 sec total (?)
 Check volume @ COTA stops residents
 say it's hi-volume.
 plans for overpass / link to bike paths
 ppl accessing COTA stops from mult.
 apts nearby
 70 ft across Livingston @ Brice SB
 car
 SW side of Brice sidewalks = 5ft; E = 4ft
 10ft cur Brice NB crosswalk
 ~ 12ft vehicle lanes 70ft WB Livingston
 crosswalk

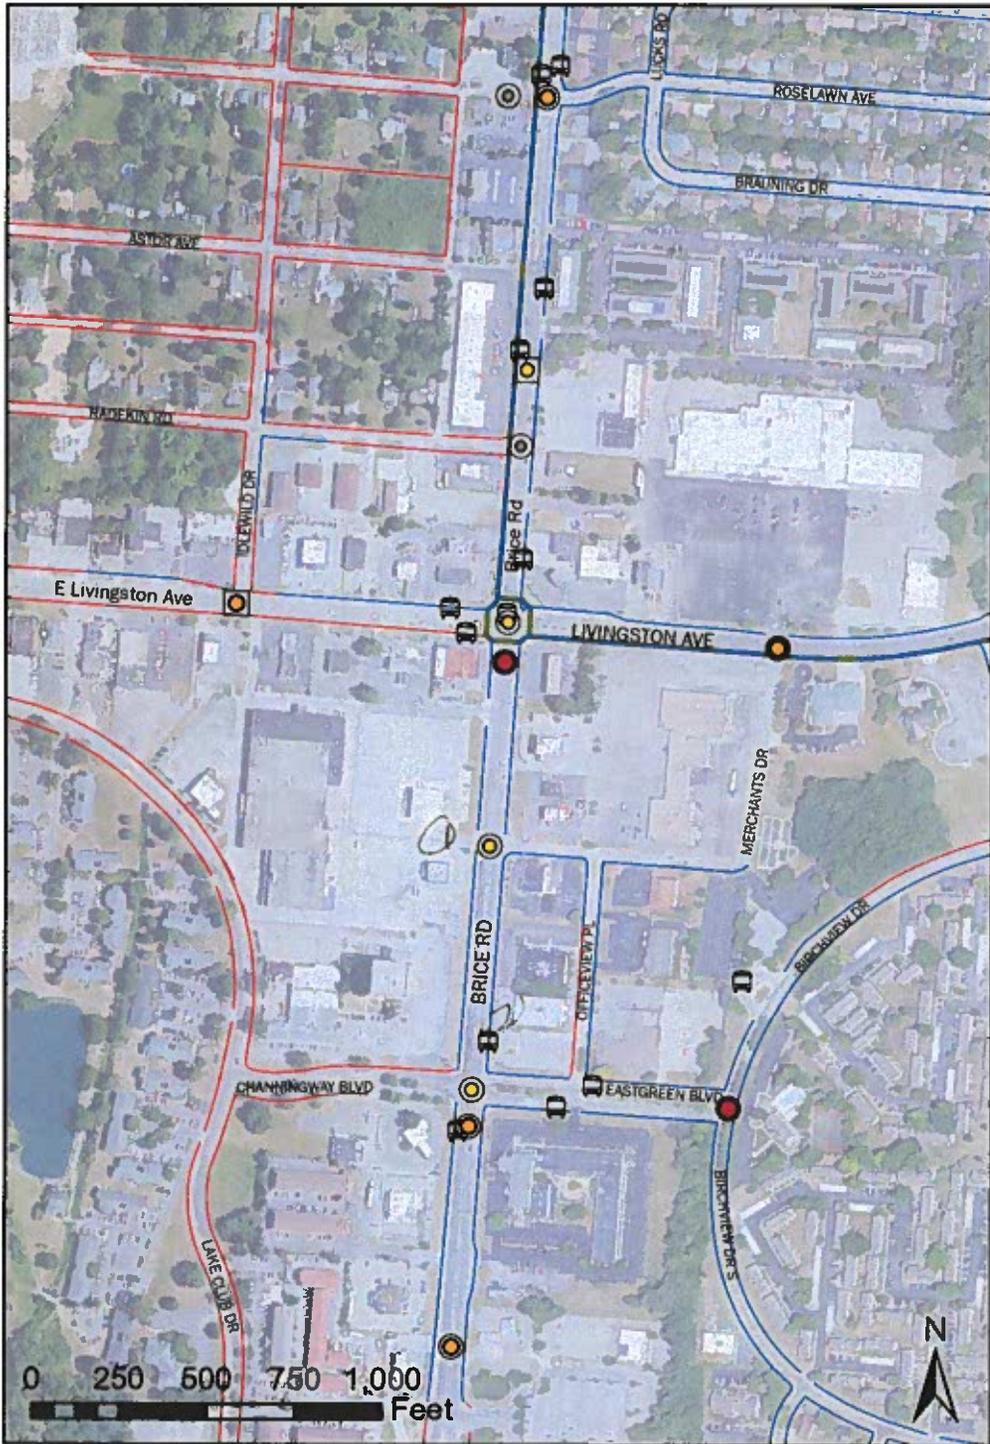
Merchants Dr cross walk was faded out, unable to see.

Notes:

- ① could put crosswalk here
- ② too many high volume stops, don't have the facilities of high volume stop
