Franklin County Public Health
Complete Streets Safety Audits

City of Grove City Walk Audit Summary Report

Stringtown Road at Parkway Centre

APRIL 2022

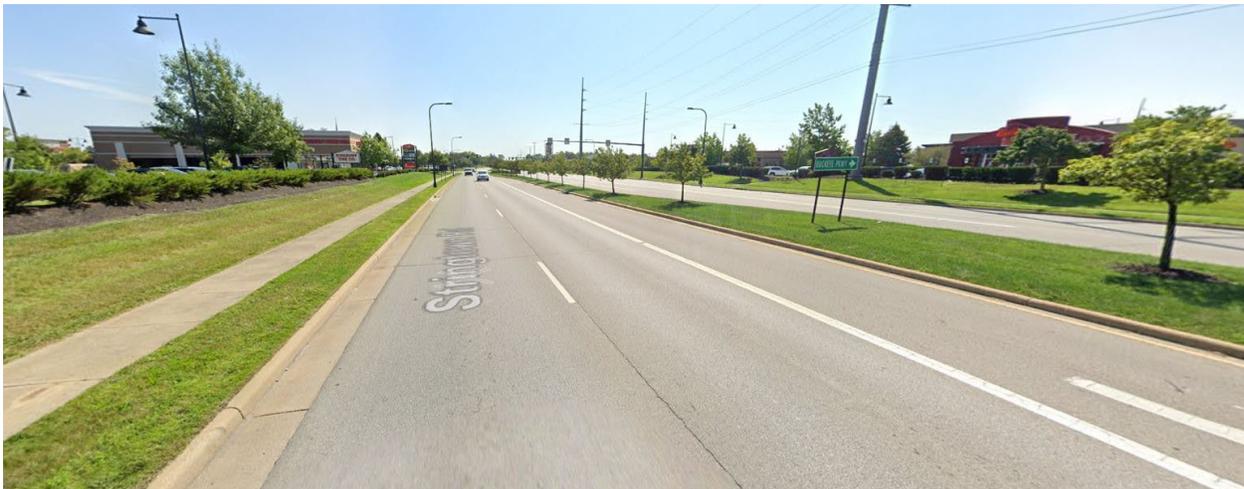
Figure 3 – Google Streetview Image of Stringtown Road

The Stringtown Road corridor is a minor arterial with a posted speed limit through the study area of 35 MPH. Data available through the Ohio Department of Transportation (ODOT) indicates that the Annual Average Daily Traffic (AADT) volumes along the corridor are around 30,000 vehicles per day. The corridor is primarily two vehicular travel lanes in each direction, with the addition of turn lanes at intersections. The vehicular lanes vary in width depending on location along the corridor, but in general are quite wide – ranging from 12 feet to 15 feet wide. For much of the corridor there is also a large center median with landscaping. The curb-to-curb width of the roadway ranges from approximately 68 feet at the narrowest point to 114 feet wide at the widest point. A narrow buffer of approximately 4 feet exists between the curb and the sidewalks on each side of the roadway. The existing sidewalks are approximately 5 feet wide on both sides.

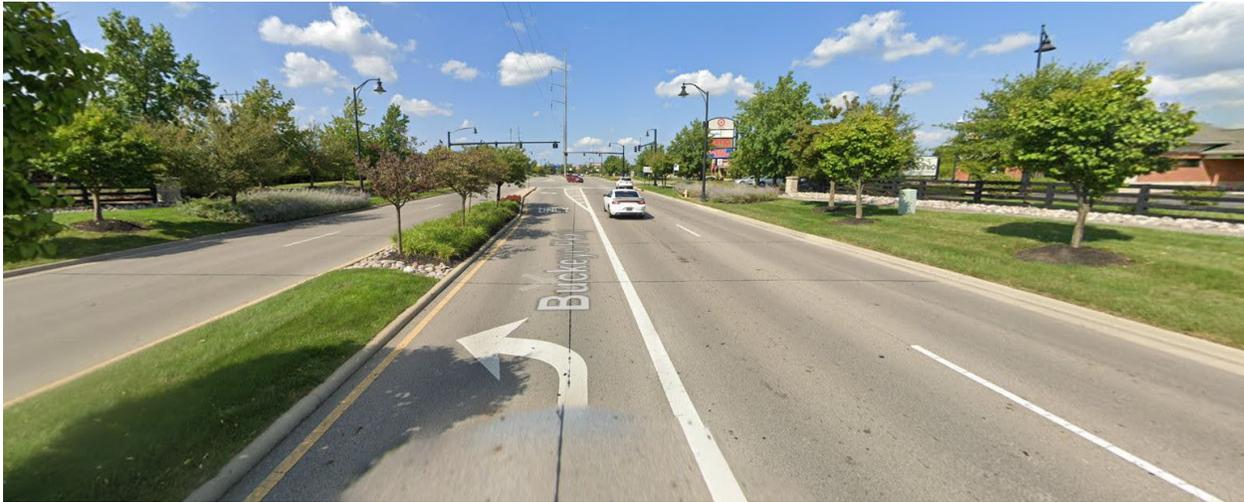
Figure 4 – Google Streetview Image of Buckeye Parkway

Buckeye Parkway is also a minor arterial with a posted speed limit through the study area of 35 MPH. Data collected in June of 2021 indicates that the Annual Average Daily Traffic (AADT) volumes along the corridor are around 11,000-12,000 vehicles per day. The corridor is similar to Stringtown Road with primarily two vehicular travel lanes in each direction, and the addition of turn lanes at intersections. The vehicular lanes along Buckeye Parkway also vary in width depending on location along the corridor, ranging from 12 feet to 14 feet wide. Most of the corridor also has a large center median with landscaping. The curb-to-curb width of Buckeye Parkway is more consistent than Stringtown Road, at approximately 76 feet wide throughout the study area.

The design of this corridor is more of a “boulevard” and it includes more decorative landscaping and streetscape amenities than Stringtown Road. There is more of a buffer present along Buckeye Parkway between the curb and the walkways on each side of the roadway. There is also an 8-foot wide asphalt path along the east side of the roadway for shared use by pedestrians and bicyclists.

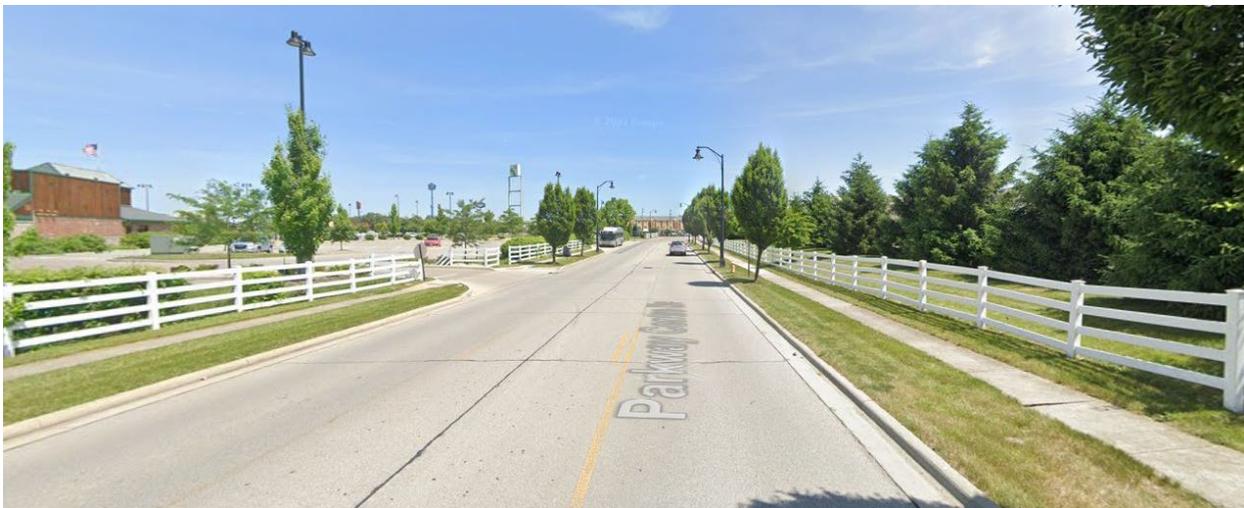
Figure 5 - Google Streetview Image of Parkway Centre Drive

Parkway Centre Drive is a local street with a posted speed limit through the study area of 35 MPH. Data on vehicular traffic volumes for this corridor was not available at the time of this study. This corridor is much narrower than the two previous, with only a single vehicular travel lane in each direction, and a center two-way left-turn lane. The vehicular lanes are each approximately 12 feet wide, and the corridor has a total curb to curb width of approximately 36 feet. A buffer of approximately 5 feet exists between the curb and the sidewalks on each side of the roadway. The existing sidewalks are approximately 4 feet wide on both sides.

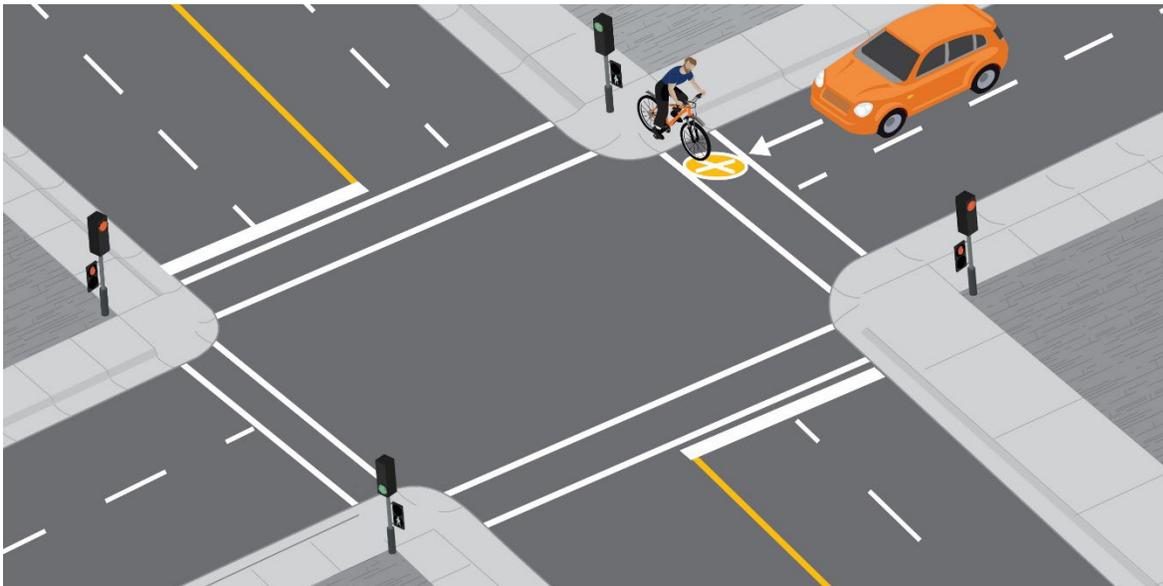
Figure 6 - Crash Type: Bicyclist Traveling on Sidewalk

- A crash involving someone bicycling resulted in a serious injury. This crash occurred at the intersection of the I-71 northbound exit ramp with Stringtown Road. The person bicycling was traveling eastbound on the sidewalk along the southern side of Stringtown Road and entered the intersection with the I-71 northbound ramp (potentially against the signal). A motorist exiting the freeway made a right-turn onto Stringtown Road and struck the person bicycling in the crosswalk. The person bicycling was reported as 57 years old, and the motorist was reported as 41 years old. The image in Figure 6 illustrates the scenario that occurred in this crash.

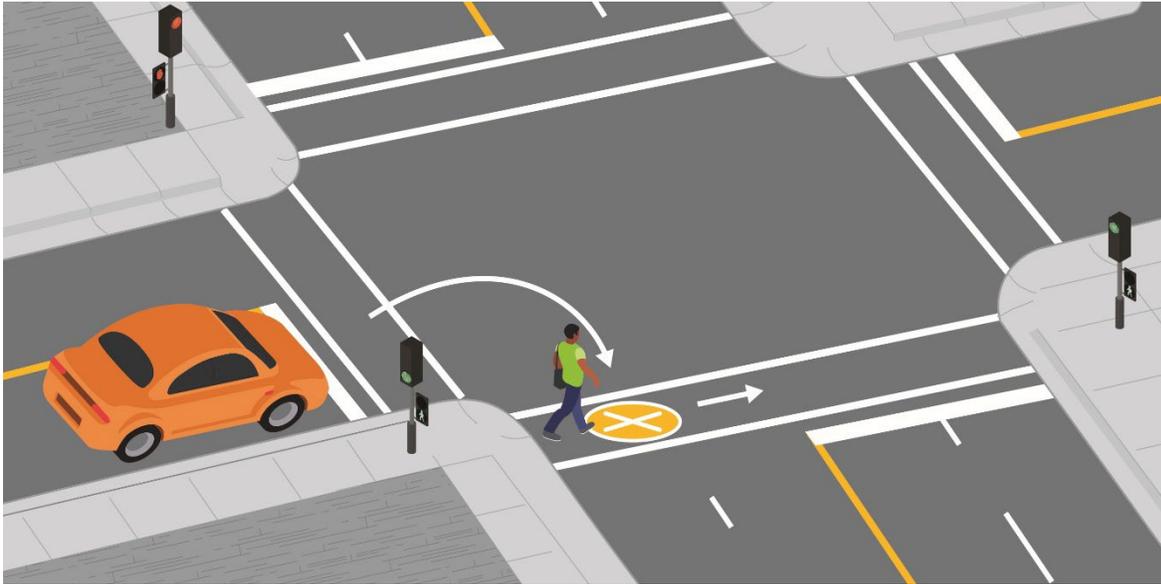
Figure 7 - Crash Type: Turning Vehicle at Intersection

- A crash involving someone walking at Stringtown Road and Thistlewood Drive resulted in a minor injury. The person walking was traveling southbound along the west side of Thistlewood Drive and crossed Stringtown Road with the pedestrian signal. A motorist traveling in the same direction made a right turn onto Stringtown Road and struck the person walking in the crosswalk. The person walking was reported as 62 years old, and the motorist was reported as 67 years old. The image in Figure 7 illustrates the scenario that occurred in this crash.

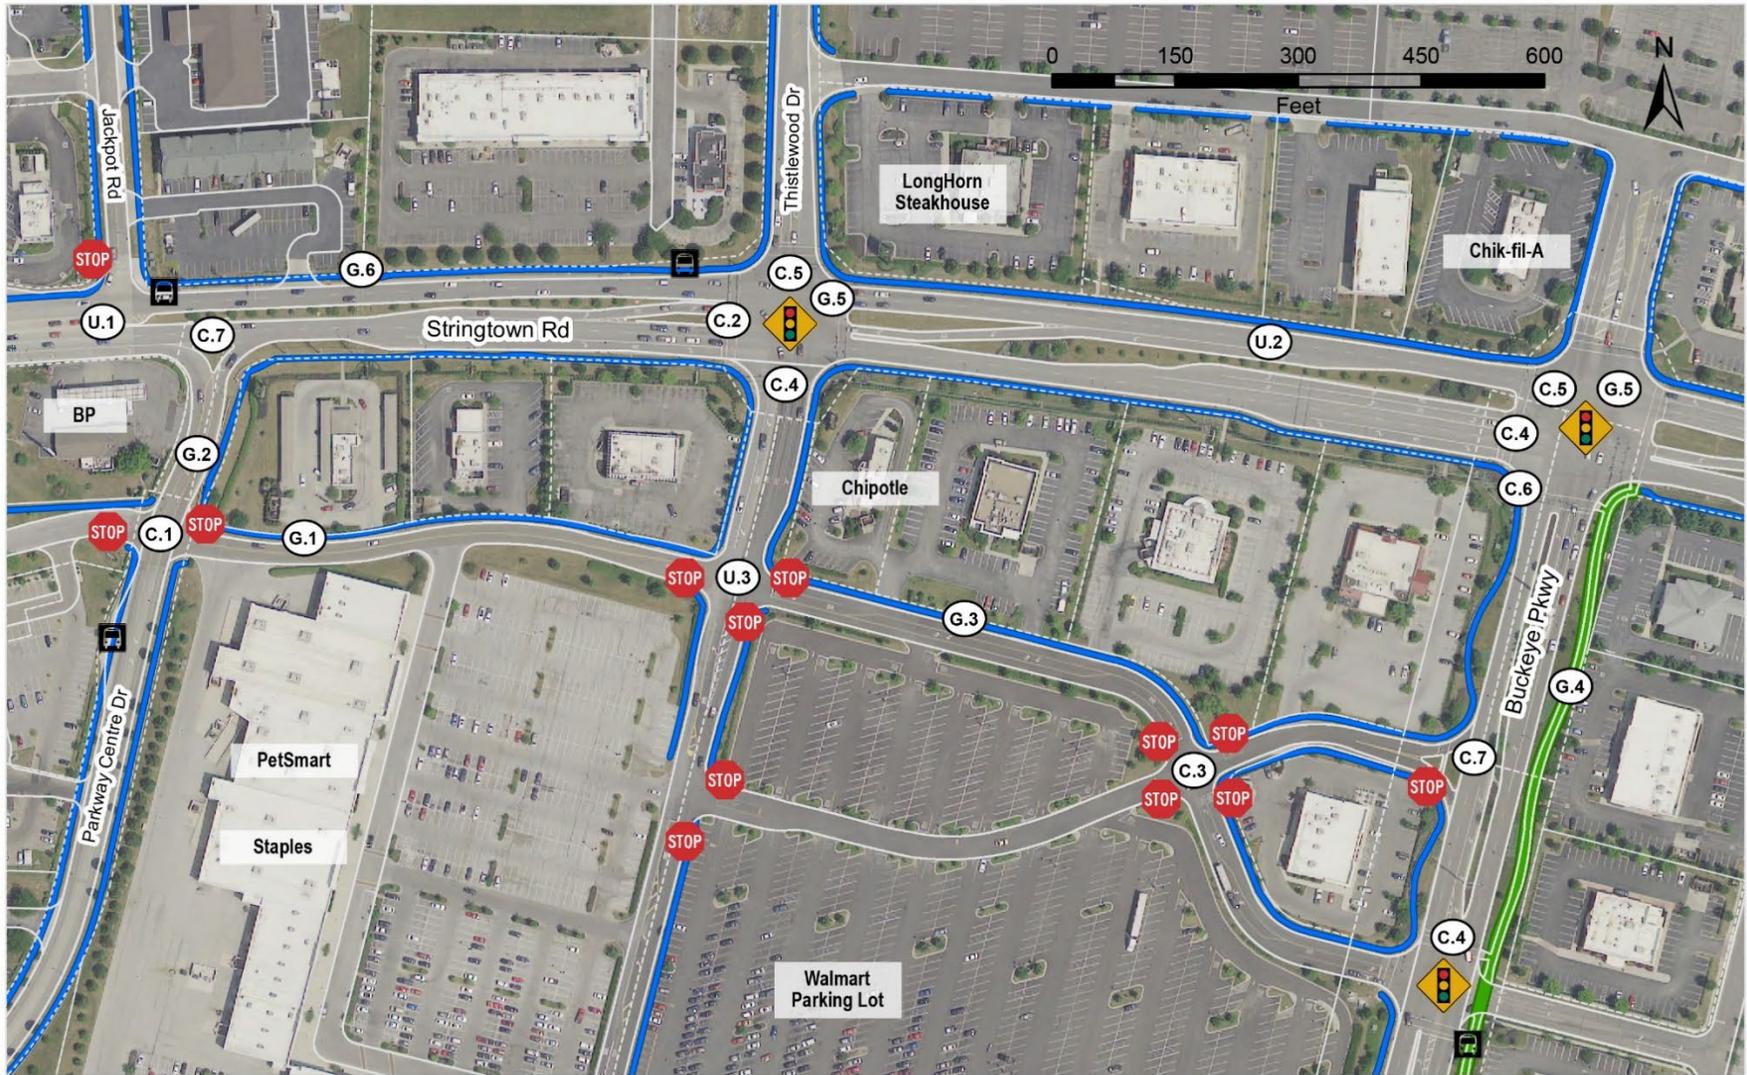
Figure 10 - Map of Walk Audit Observations

The following section highlights observations that were made by the Walk Audit team. These observations are categorized as General Infrastructure, Crossings and Intersections, User Behavior, and Environment. The chart in Figure 9 summarizes these observations and the map in Figure 10 illustrates the locations of each observation. Each observation is outlined in further detail on the following pages, along with recommendations for potential improvements.

- Pedestrian crossing time at signals felt short to participants (all of whom were able-bodied pedestrians)
- Many participants commented on poor driver yielding rates

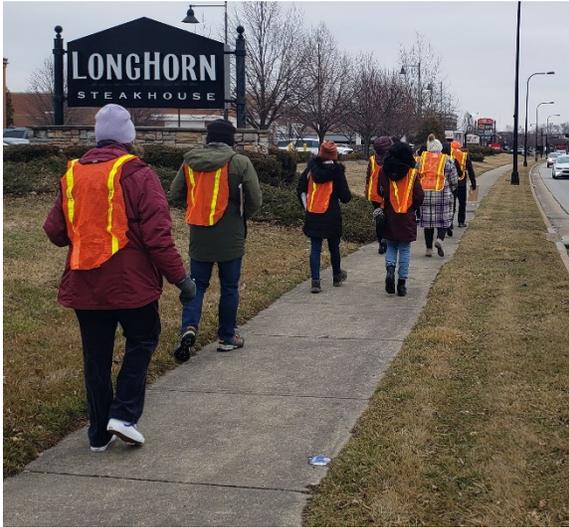
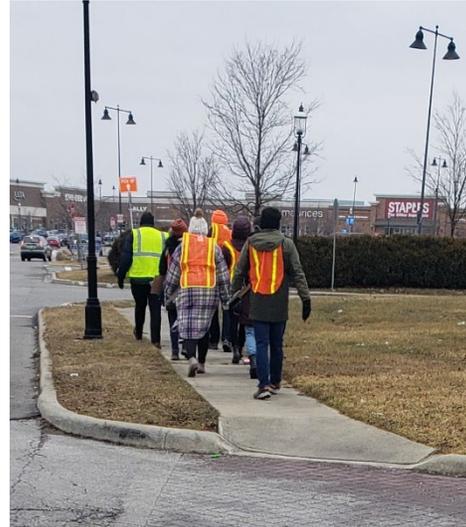
Observation #1: Narrow Sidewalk Widths

North Side of Stringtown Road (5-foot Sidewalk)

Parkway Centre South (< 4-foot Sidewalk)

The existing sidewalks *within* the Parkway Centre development are approximately 4 feet wide (sometimes less). This is not wide enough for two people to walk side-by-side, or pass each other comfortably traveling in opposite directions. A 5-foot wide sidewalk provides the minimum space necessary for two people to walk side-by-side, or to pass each other comfortably.

Standard sidewalk widths should be a minimum of 4 feet wide in constrained conditions, with a preference for 5 feet as a minimum. A sidewalk wider than 5 feet is preferred as pedestrian volumes increase, and would be more desirable for a major commercial corridor such as Stringtown Road.

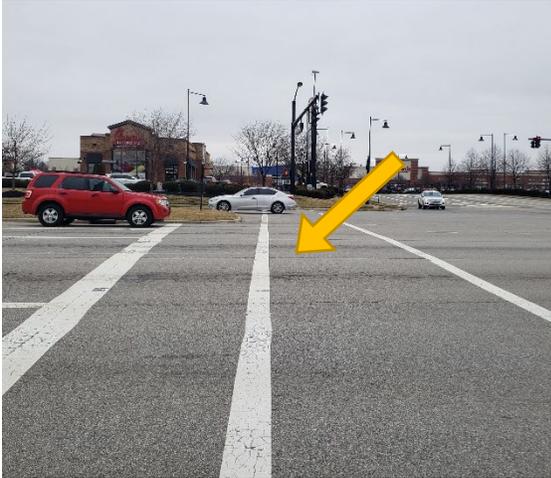
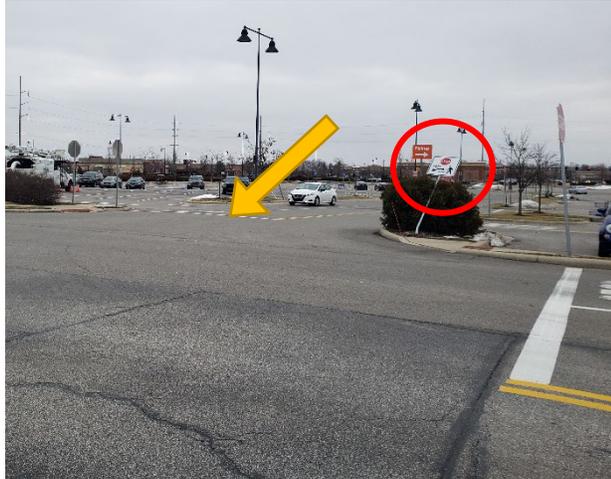
Observation #2: Low Visibility and Faded Crosswalk Markings

Intersection of Stringtown Rd & Buckeye Pkwy

Intersection within Parkway Centre South

The existing pedestrian crossing markings throughout the study area are standard, transverse lines that fade quickly in areas with high vehicular traffic. These markings are considered low visibility, and are often mistaken as stop bars by motorists stopping at intersections – especially once they have started fading. This can create potential conflicts, as motorists may not be aware of the crosswalk or expect there to be people crossing the street in front of them. It is also common for motorists to pull forward into the crosswalk and block the crossing for pedestrians. Additionally, there are many intersections throughout the Parkway Centre development that *do not currently have* pedestrian crossing pavement markings, though some are marked with “Stop Here for Pedestrians” signage.

High visibility crosswalk markings are recommended for use as the standard crosswalk marking. They are more visible to motorists, have been shown to increase yielding behavior of motorists, and can be implemented in a manner that reduces wear and maintenance requirements. High visibility crosswalk markings include three general types: longitudinal bars/continental, ladder, and bar pairs. Existing crosswalk markings can be upgraded to high visibility markings as they require maintenance, and intersections that do not currently have any markings should be marked with high visibility markings.

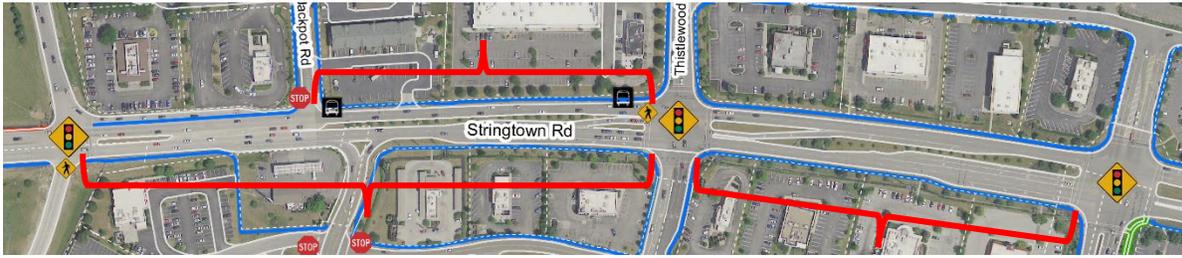
Observation #3: Distance Between Pedestrian Crossings

Stringtown Road Pedestrian Crossing Locations

I-71 Ramp Intersection
to Thistlewood Dr
1,200'

Jackpot Rd to
Thistlewood Dr
750'

Most people will not walk more than three (3) minutes, or 600-800 feet, out of their direction of travel to cross the street. This is particularly true for people who need to cross the street to catch a bus, or who are crossing the street after exiting a bus. It is recommended that the City collaborate with ODOT to evaluate the potential to add a formal pedestrian crossing at Jackpot Road or Parkway Centre Drive.

For a corridor such as Stringtown Road, these crossings (and any mid-block crossings) would require high visibility crosswalk markings and additional infrastructure treatments (e.g., median or pedestrian refuge island, rectangular rapid-flashing beacon or pedestrian hybrid beacon, etc.) in order to provide an adequately safe crossing. The ODOT MMDG recommends following existing guidance provided by the FHWA for designing uncontrolled pedestrian crossings. (4.4.3. *Selecting Pedestrian Crossing Treatments*)

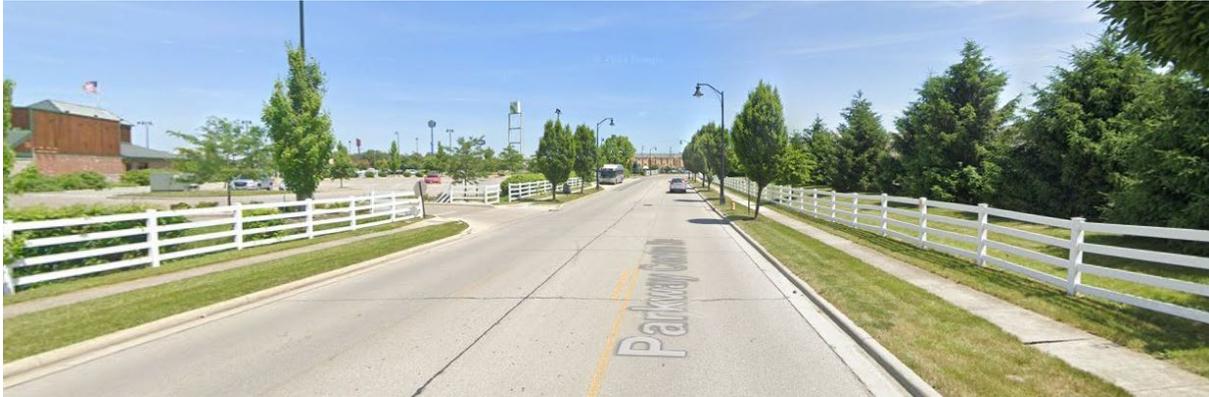
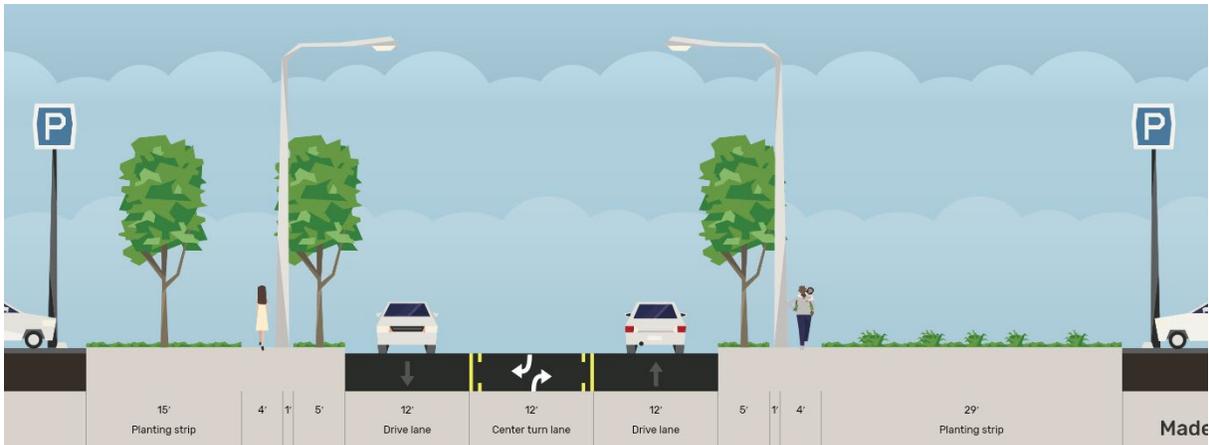
Observation #4: Parkway Centre Drive Opportunity

Parkway Centre Drive (facing north)

Parkway Centre Drive is approximately 36 feet wide from curb to curb and has three 12-foot wide vehicle lanes. The center lane is currently used for a continuous two-way left-turn lane that only serves a few driveways.

Parkway Centre Drive is identified in the GroveCity2050 plan as a “Local Street” within a “Commercial Center” land use. According to these designations, the recommended width for vehicular travel lanes is between 9-11 feet wide. Additionally, priorities for this type of street include sidewalks with a minimum width of 5 feet, as well as street trees and other streetscape amenities. Medians and bicycle facilities are not indicated as high priorities, but are a logical consideration in the context of the larger Parkway Centre development and existing street design character and multimodal networks.

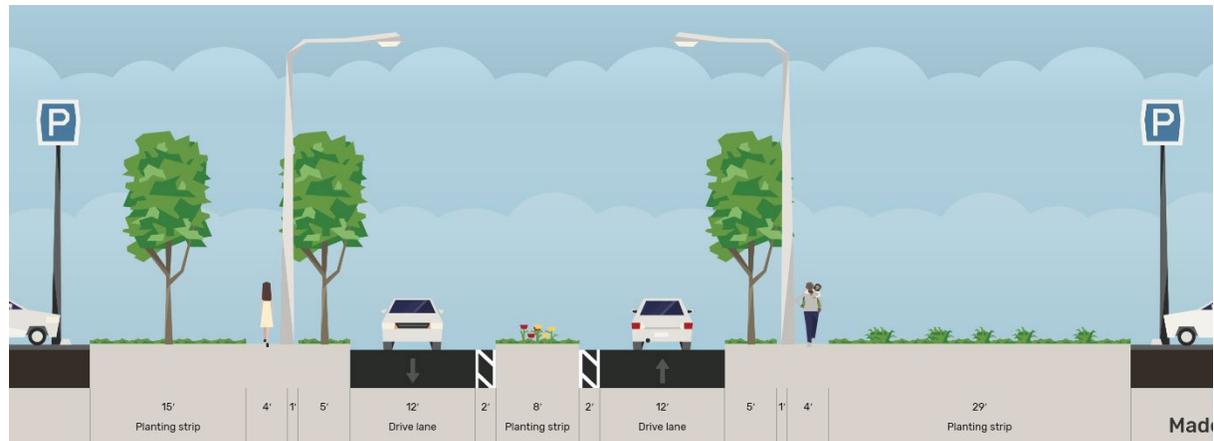
1. Addition of a center median with landscaping

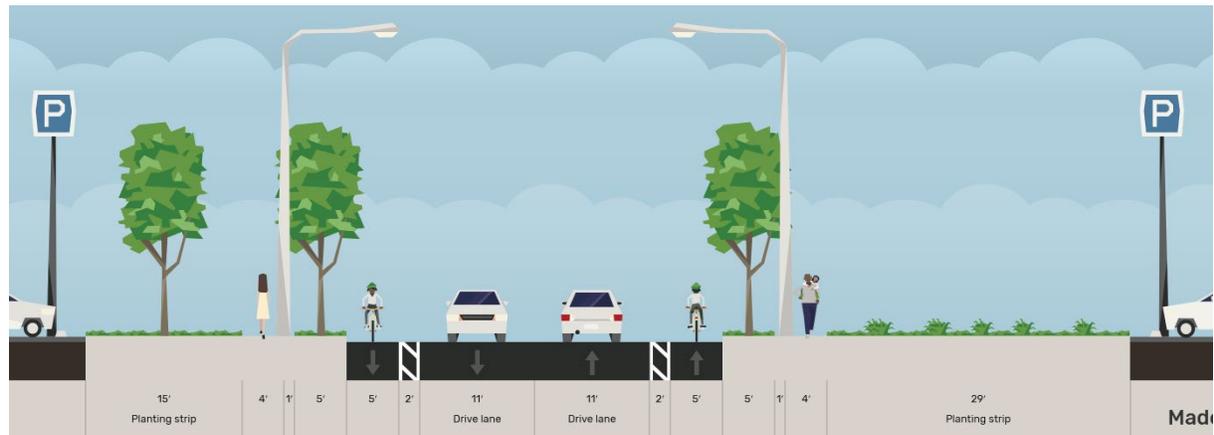
2. Removal of center turn lane to accommodate bicycle lanes

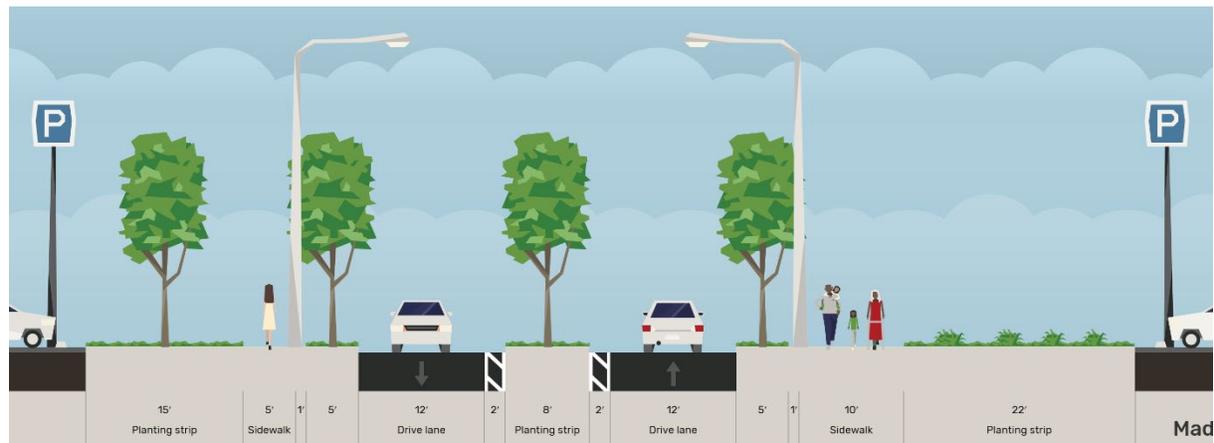
3. Addition of a center median with landscaping and widening of existing sidewalks

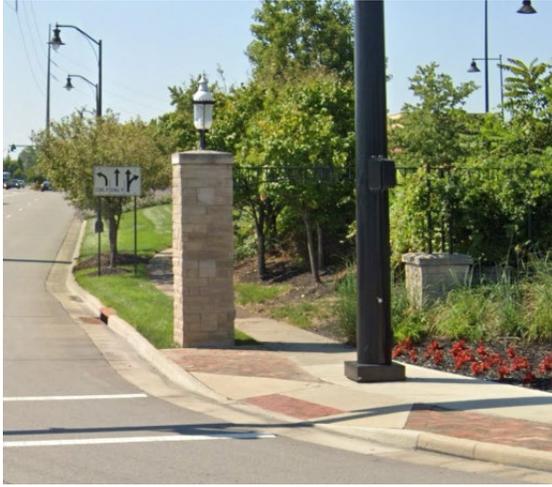
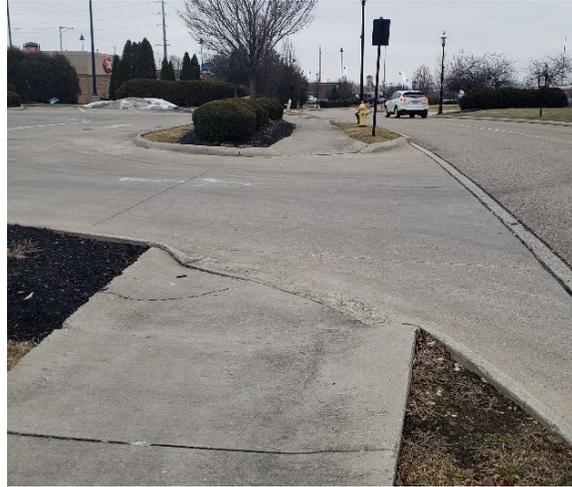
Observation #5: Accessibility Challenges

Intersection of Stringtown Road
and Buckeye Parkway

Driveway along internal access road
of Parkway Centre South

Traffic signal poles and other infrastructure placed within the right-of-way represent obstacles for those who are visually and/or mobility impaired. A traffic signal pole at the intersection of Stringtown Road and Buckeye Parkway was located such that an ADA-accessible route does not exist around the southwest corner of the intersection.

Consideration should be given to the future placement of (and potential relocation of existing) signal poles and other infrastructure within the right-of-way to ensure that ADA-accessible paths (recommended minimum continuous sidewalk width of 4 feet) are provided with all sidewalk/pedestrian facilities.

Detectable Warnings should not be used indiscriminately, as that may create more confusion for those who are visually impaired. The ODOT MMDG recommends the use of Detectable Warnings at “driveways with heavy traffic, a signal, a stop sign, or a yield sign that make their crossing comparable to a street.” (4.5.9.4 *Detectable Warnings*)

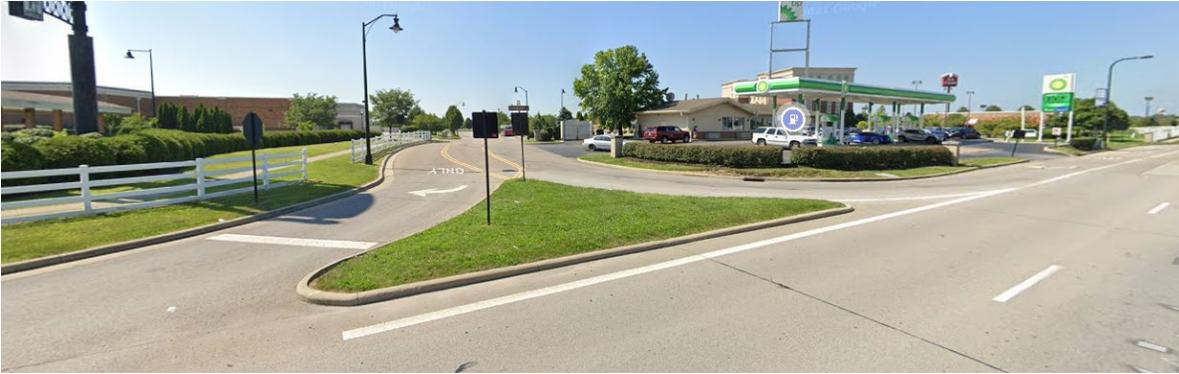
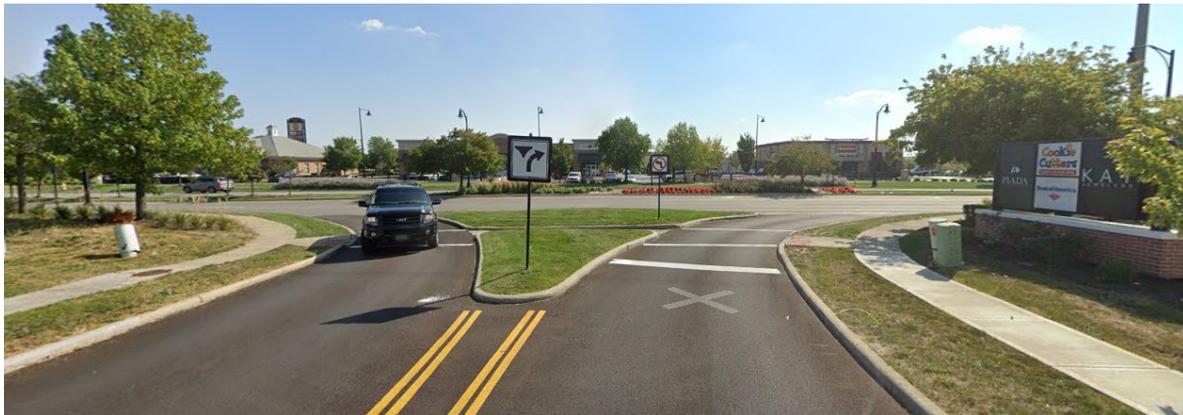
Observation #6: Channelized Right Turn Lanes

Right-turn only intersection at Stringtown Road and Parkway Centre Drive

Right-turn only intersection at Buckeye Parkway and Parkway Centre access road

If an additional pedestrian crossing is implemented at Jackpot Road or Parkway Centre Drive across Stringtown Road, it is recommended that the sidewalk and pedestrian pathway be continued along the south side of Stringtown Road across Parkway Centre Drive and in front of the BP Gas Station. This would require the addition of an appropriate pedestrian crossing through the Parkway Centre Drive access point and channelized turn lanes.

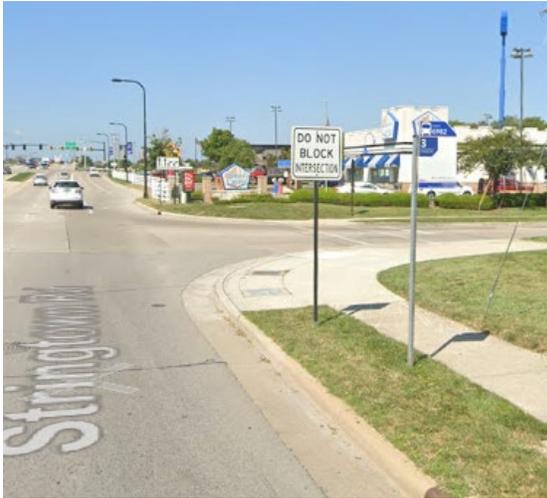
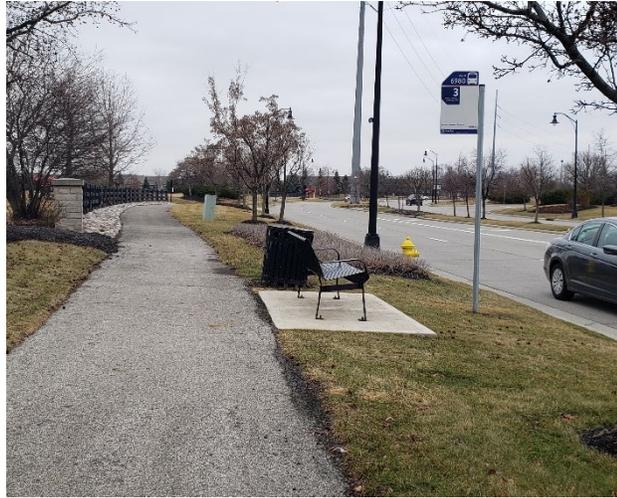
Observation #7: Transit Services and Bus Stops

Bus Stop at Jackpot Road and Stringtown Road

Bus Stop at Buckeye Parkway and Intersection for Parkway Centre East

COTA Route 3 currently operates through the Parkway Centre area at a standard frequency of approximately 30-minute headways. It travels along Stringtown Road to Parkway Centre Drive, Buckeye Place, and Buckeye Parkway to loop back around and return north to Columbus. The busiest stop location in the area is at Parkway Centre Drive just after the bus turns off Stringtown Road. The stop amenities provided at this location reflect how busy the stop is. There is a bus pull-off with a sheltered waiting area, bench, and trash receptacle.

It is recommended that every bus stop location be upgraded to include (at minimum) an accessible boarding and alighting area, as required by ADA and PROWAG. This requires an area no less than 5 feet in width parallel to the curb and 8 feet in depth perpendicular to the curb that is free of any obstructions. This pad may be a part of the pedestrian pathway or sidewalk.

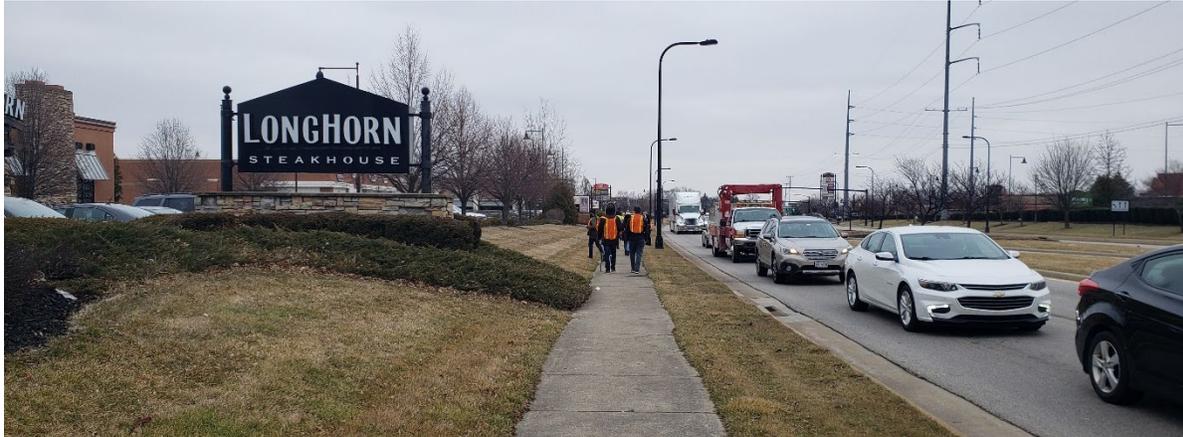
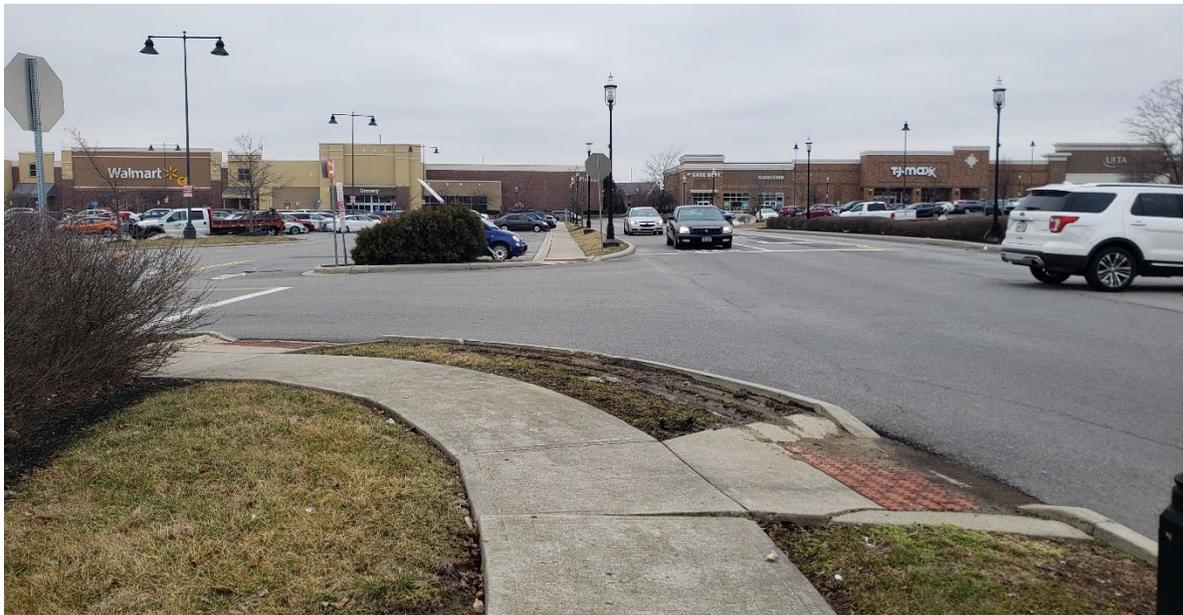
Observation #8: General Walking Environment

Overhead Lighting and Streetscape Conditions throughout Parkway Centre

Overhead street lighting exists throughout the Parkway Centre development, though the scale and style of lighting varies by location. Much of the overhead lighting is designed and oriented to light the roadway and/or parking areas. However, within the development itself, there is some smaller scale lighting that better serves the purpose of lighting the pedestrian walkways.

As noted in GroveCity2050, the Parkway and Boulevard street types within the Commercial Context (e.g., Stringtown Road and Buckeye Parkway) should prioritize landscaping, street trees, buffer zones, wide sidewalks, medians, and separated bicycle facilities. The vehicular travel lanes on these corridors could also be much narrower (around 11 feet wide instead of 12-14 feet wide).

Recommendations for improvements to these corridors and/or design of similar corridors in future developments could include minimizing the width of the vehicular travel lanes to accommodate wider buffers with street trees and other amenities (wide sidewalks, separated bicycle facilities, etc.) as suggested in GroveCity2050.

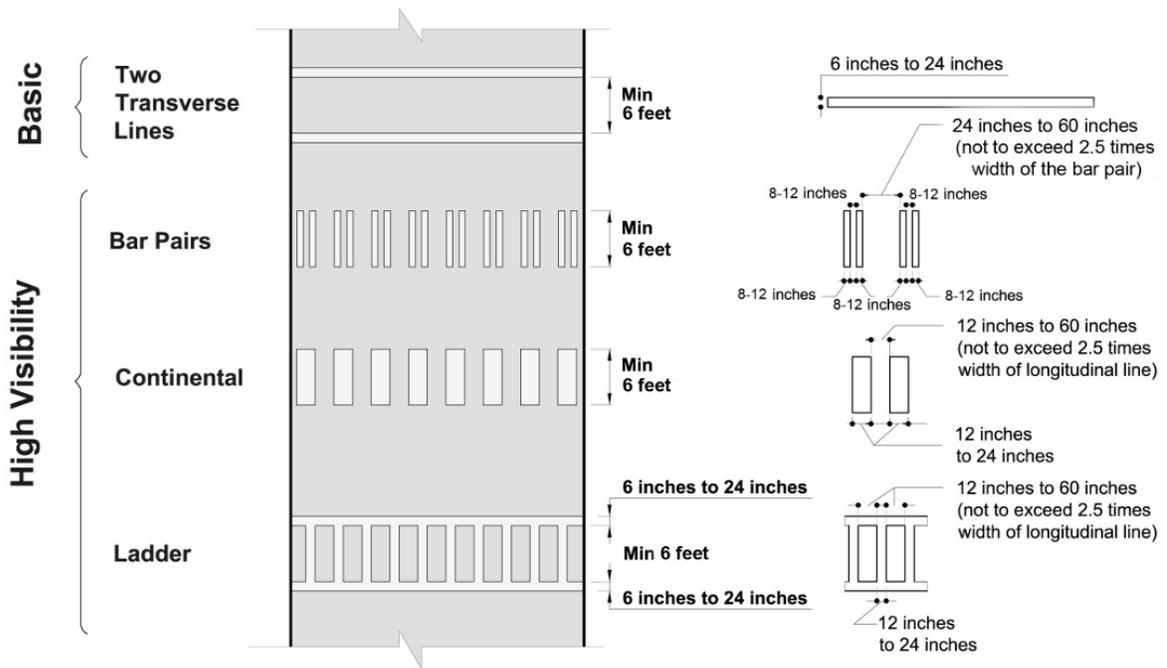
Crosswalk Marking Types

The image below was proposed by the National Committee on Uniform Traffic Control Devices to replace the existing Figure 3B-19 in the Manual on Uniform Traffic Control Devices (MUTCD). The image displays examples of crosswalk markings and classifies them as basic or high visibility.

Note: At a non-intersection uncontrolled pedestrian crossing where the speed limit is greater than 35 mph, the high visibility crosswalk marking, if used, should not be less than 8 feet wide.
